3. PHYSICAL EVIDENCE

3.1. INTRODUCTION

This section is based on a survey that was carried out in February 2003. The physical evidence was assessed by means of a thorough investigation of the context, the site and the landscape, plantings and structures that combine to form *Hyde Park*.

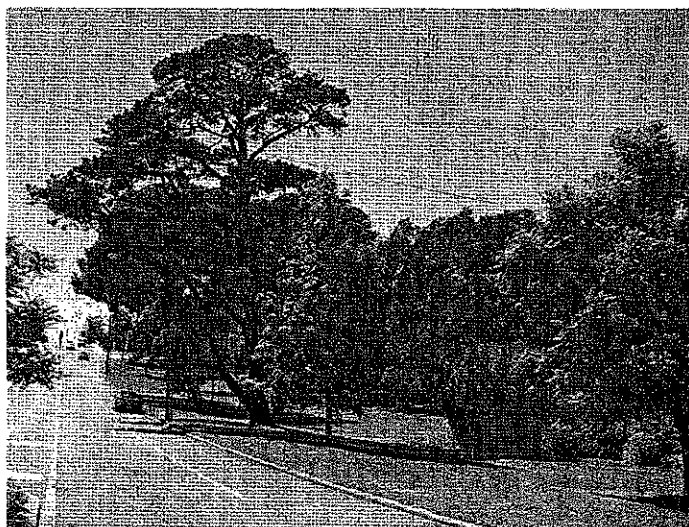
Record Photograph 3
Looking east down Vincent Street towards the intersection with William Street. Note the remnants of the lineal planting of pine trees that once formed an edge to the park.
(April 2003)

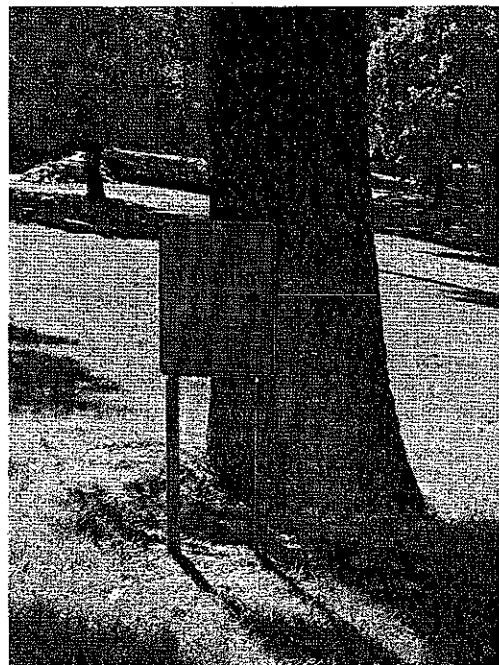
Record Photograph 15
Warning sign under Bunya Pine. (April 2003)

For safety reasons the report also recommended that temporary fencing be installed at the base of the Bunya Pines *Araucaria bidwillii* during the fruiting season as the heavy cones are dangerous to people using the park.¹

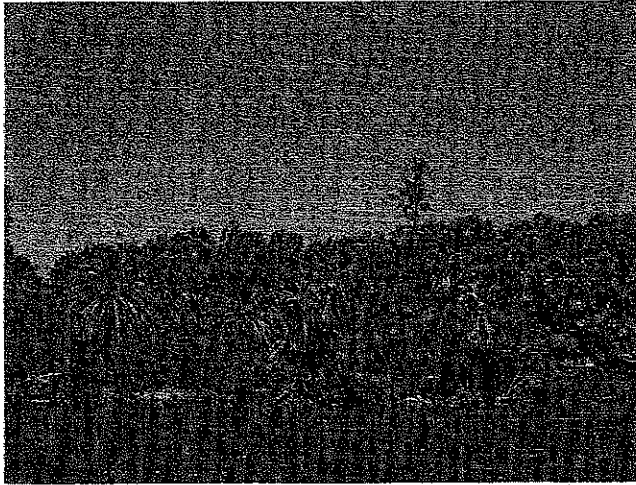
The island in the centre of the West Lake is in a very poor state of repair and it is collapsing into the lake leaving parts of the former island submerged. There are remnant plantings of exotic trees and palms on the island from when it was a manicured garden in the early Twentieth Century. These remnants include a number of Canary Island Date Palms *Phoenix canariensis*, some Cotton Palms *Washingtonia robusta*, a Weeping Willow and Pampas Grass. There are also a large number of younger Cotton Palms on the island that would appear to be self seeded.

In the centre of the island there is a metal frame lying on the ground. This frame was a standard light that was used in the past to illuminate the lake at night and has now fallen over.

Record Photograph 41
West Island.
(April 2003)

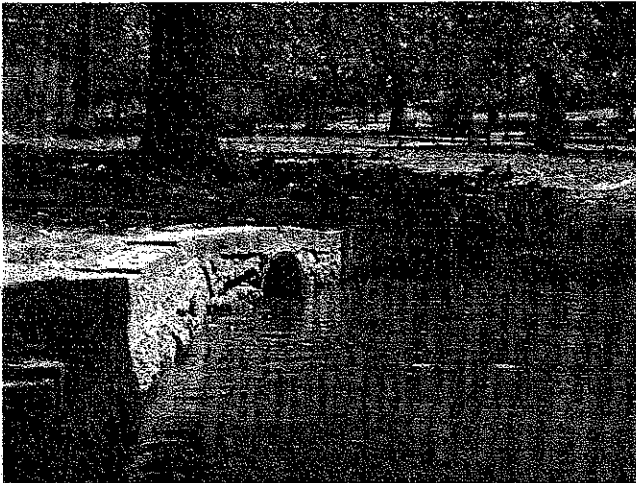
The banks of the East Lake are lined by an avenue of mature Plane Trees *Platanus x hispanica*. These umbrageous trees form a giant hedge surrounding the lake, a homogenous backdrop for the more exotic and somewhat chaotic planting on the central island. Due to the shade there is no grass beneath these trees, only bare dirt. There are a number of park benches located in this area facing towards the lake. The bank formed by the causeway is also planted with Plane Trees but these trees are located further apart than on the other banks allowing a grass lawn to be established beneath them and for a number of palm trees to flourish between the trees. All the banks of the East Lake are retained by a low limestone wall with a concrete cap that appears to have been raised several times as the lake bed has risen with the accumulation of sediment. Numerous tree roots can be seen growing through the wall.

Record Photograph 48
Detail of retaining wall to the edge
of lake.
(April 2003)

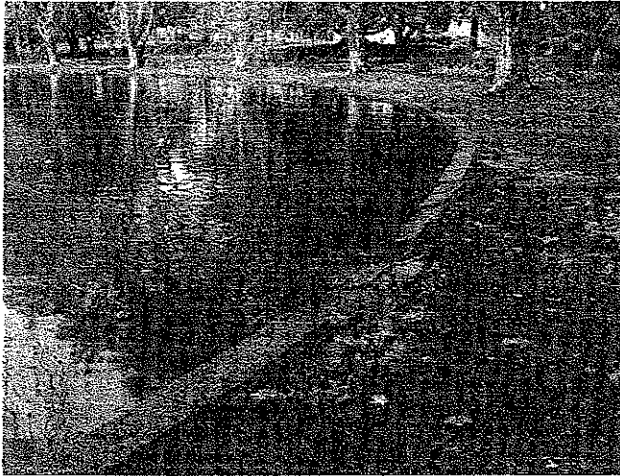
**Record Photograph 50**

West Lake flooding during winter rains. Note the deteriorated capping to the limestone wall edging the lake. (June 2003)

The documentary evidence suggests that the limestone walls to the edges of the lakes have, since their construction, undergone a series of repairs and that they have been raised in height. In places these walls are in poor repair and the concrete capping is loose or missing.

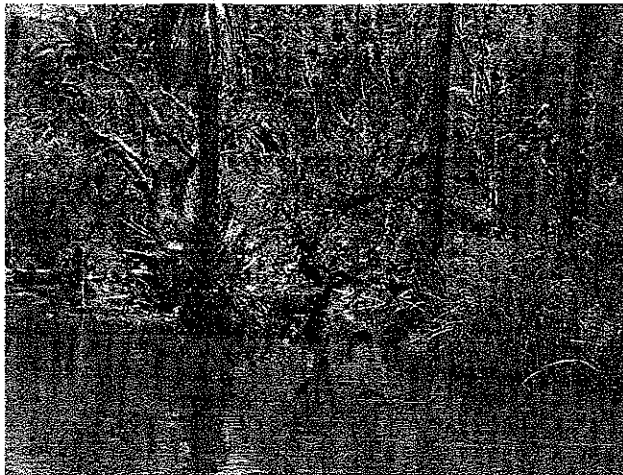
**Record Photograph 51**

The island in the West Lake is in very poor condition. Following the recent dredging of the West Lake, parts of the island have collapsed into the lake leading to the inundation and death of certain trees and shrubs and the reduction in the depth of the lake. Structurally the East Island would appear to be in fair condition but the planting is in poor condition because it has been overgrown by Spanish Reed or Bamboo. The Spanish Reed was part of the original planting scheme but it has spread throughout the island and taken over from other less hardy species. The East Island was originally intended to provide a refuge for waterfowl but the undergrowth is now too dense for nesting.

West Island inundated with water during dry late summer months. (April 2003)

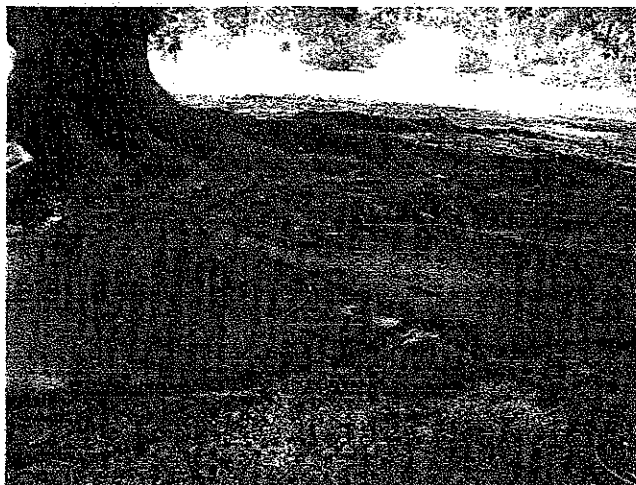
Record Photograph 52
Bitumen path being lifted by
surface feeding tree roots of a
mature Fig. (June 2003)
