70 Cowle Street, West Perth Structural Inspection Report

Mr Michael Read, M Construction
4 November 2015
Revision No. 1

Prepared by Eric Le Meur Project Number: 28285-PER-S-21
Ground Floor, 226 Adelaide Terrace, Perth WA 6000

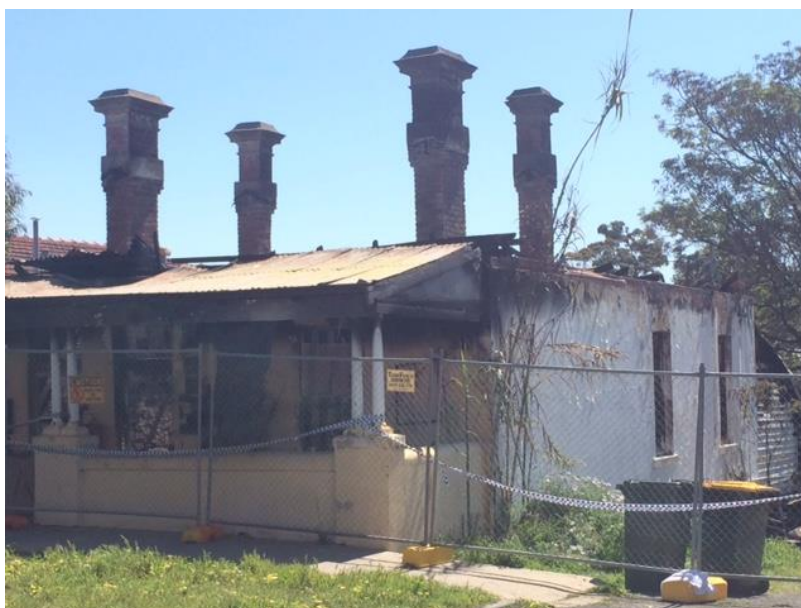
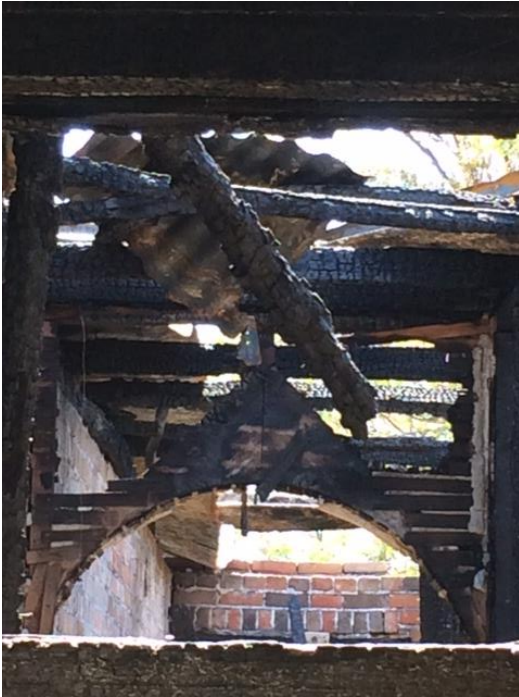
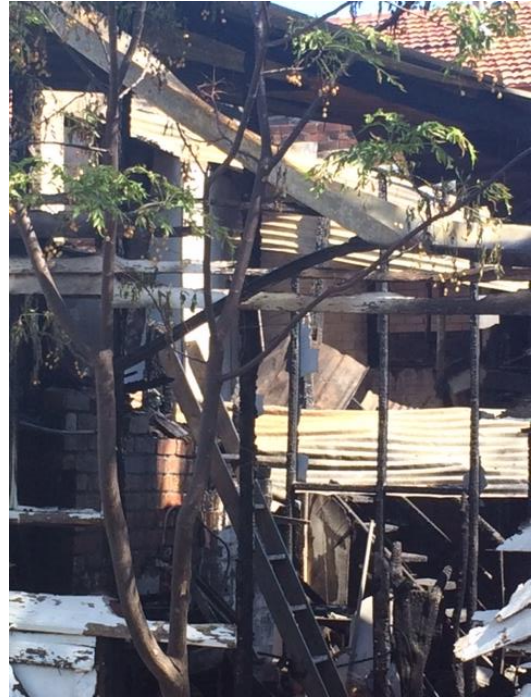
Extensive fire damage was evident throughout as illustrated in the photographs below:

- Extensive damage is evident throughout generally.
- The timber roof has been completely destroyed as a result of the fire and remaining timber members are largely charred and/or missing.

- The loss of timber roof members has removed all lateral restraint to the free-standing masonry walls. As a result, we consider the stability of most walls to have been compromised and we are of the opinion that there is a risk of collapse of existing masonry walls in some areas in the current condition.

- Cracking to existing walls was apparent in a number of locations. This is likely to have been caused by lateral wall movement and subsidence.
- The sub-floor structure appears to have been extensively damaged in a number of areas.

- The majority the timber lintels have been irreparably damaged. Tell-tales signs of masonry distress such as cracking and sagging are evident in some area as a result. These areas are at risk of further damage and/or collapse.

- Extensive render damage is evident throughout generally and little remains of existing timber window and door frames generally.
- Extensive temporary stabilisation work would be required to safe-guard the existing walls against potential collapse prior to occupying adjoining properties and allowing access to site.
