9.6 AMENDMENT TO THE TREES OF SIGNIFICANCE INVENTORY TO INCLUDE THE JACARANDA TREE AT NO. 59 ELLESMERE STREET, MOUNT HAWTHORN

**59 Ellesmere Street, Mount Hawthorn Visual Tree Assessment (VTA) –
October 2022**

*Visual Tree Assessment (VTA)
1x Jacaranda mimosifolia*

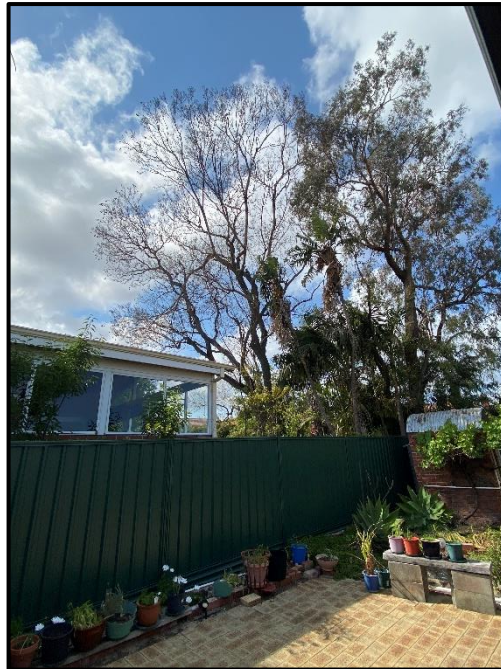
Figure 2 – Subject tree at the time of inspection (20 October 2022) Image looking South

The subject tree – *Jacaranda mimosifolia* (Jacaranda) was assessed on the 20th of October 2022. Minor structural defects were noted within the canopy; however, these flaws/defects are considered to be manageable given the appropriate arboricultural practises are applied moving forward - refer figures 2, 3 & 4 for detail.

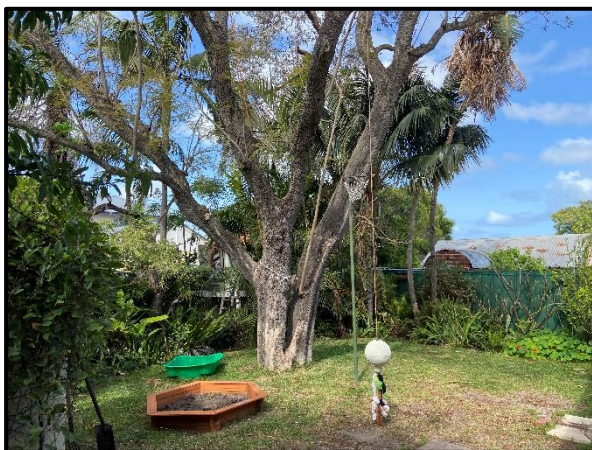
Figure 3 – Subject tree at the time of inspection (20 October 2022) Image looking South-West

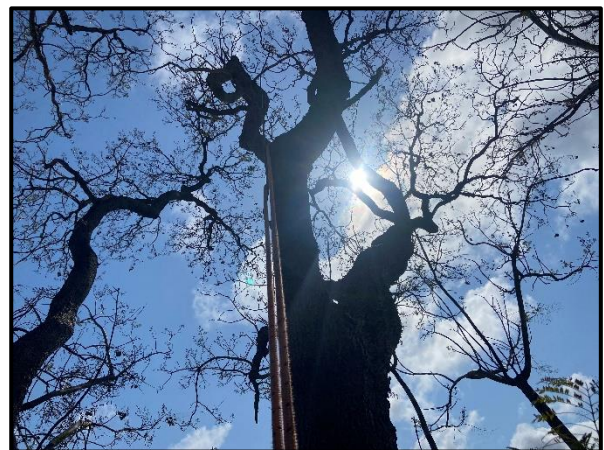
Figure 4 – Subject tree at the time of inspection (20 October 2022) Image taken during the aerial inspection

Several structural issues were observed including; previous deleterious pruning (i.e. tree has been lion tailed, however canopy structure could be remediated to offset previous works); stem failures ranging from 50 mm dia. to 150 mm in diameter; deadwood ranging to 50 mm in diameter, minor rubbing and crossing stems to 50mm, however; these issues are generally considered manageable within the scope of an ongoing, proactive tree management, canopy pruning and monitoring program.

- That Corrective/Remedial Canopy Pruning be undertaken to address structural defects that were noted in the inspection;
- Aerially inspect the remainder of the canopy for potential structural, health and/or other issues that may not be detectable from ground level.

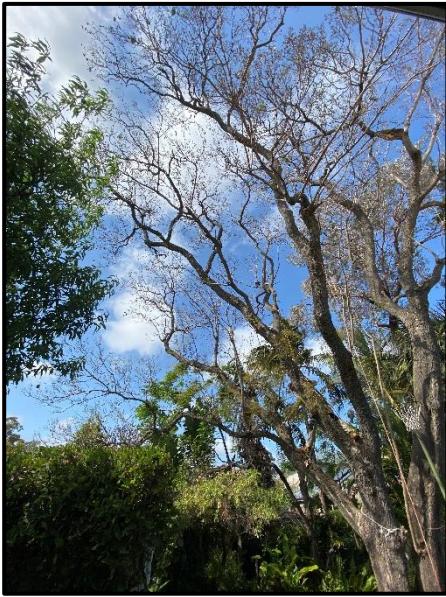
Image taken by Arbor Centre facing South – showing canopy heading toward eastern neighbour

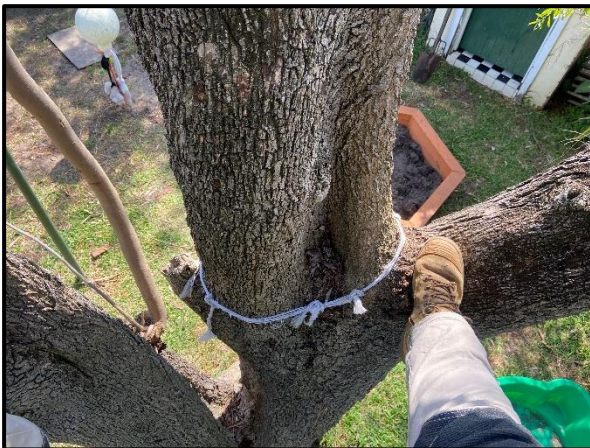
Image taken by Arbor Centre from within canopy – showing fluting within the canopy

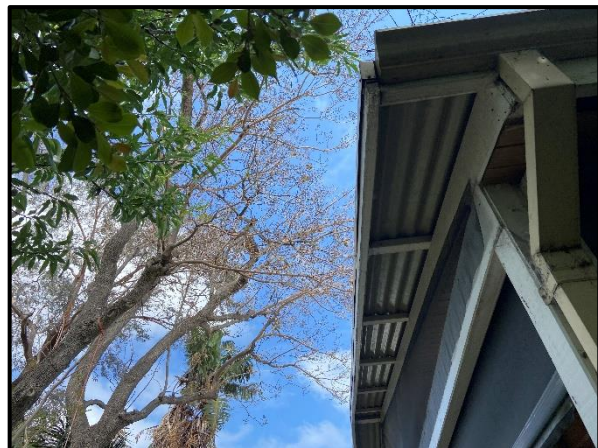
Image taken by Arbor Centre facing West – showing failed stem caught in canopy

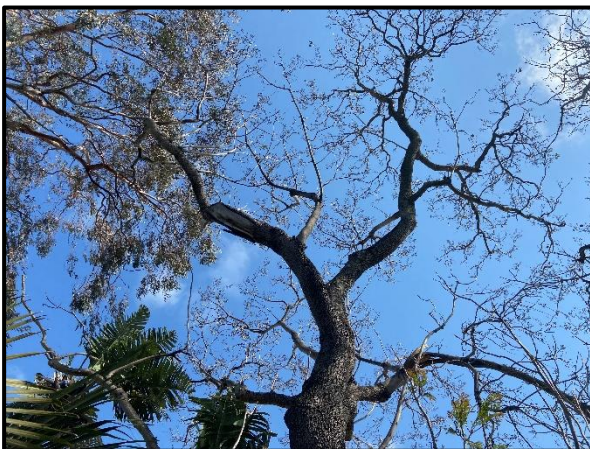
Image taken by Arbor Centre from within canopy – showing wounding from previous failures

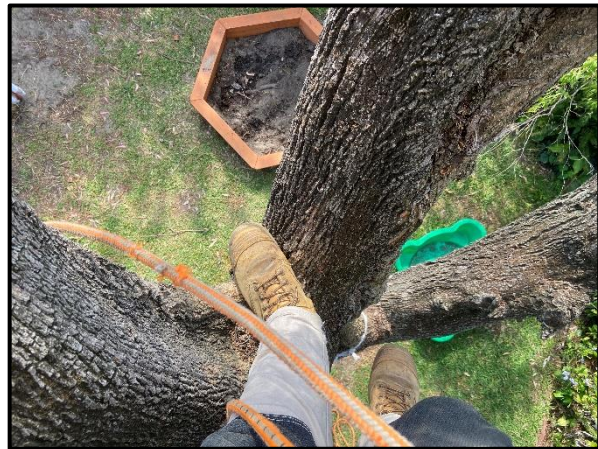
Image taken by Arbor Centre from within canopy – showing sound unions
