**5.6 AMENDMENT TO THE TREES OF SIGNIFICANCE INVENTORY TO INCLUDE THE JACARANDA TREE AT NO. 59 ELLESMERE STREET, MOUNT HAWTHORN**

**59 Ellesmere Street, Mount Hawthorn Visual Tree Assessment (VTA) –  
October 2022**

*Visual Tree Assessment (VTA)  
1x Jacaranda mimosifolia*

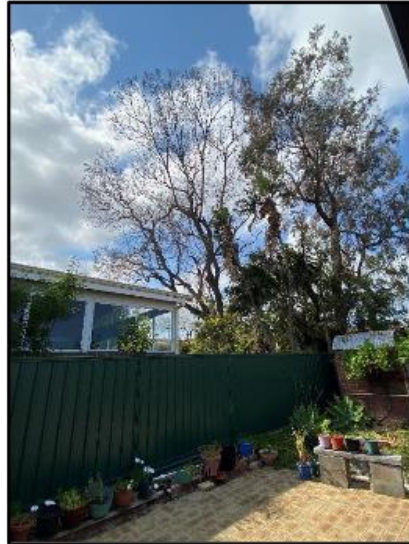
Figure 2 – Subject tree at the time of inspection (20 October 2022) Image looking South

The subject tree – *Jacaranda mimosifolia* (Jacaranda) was assessed on the 20<sup>th</sup> of October 2022. Minor structural defects were noted within the canopy; however, these flaws/defects are considered to be manageable given the appropriate arboricultural practises are applied moving forward - refer figures 2, 3 & 4 for detail.

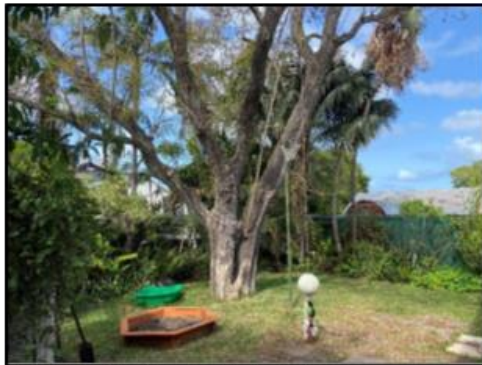
Figure 3 – Subject tree at the time of inspection (20 October 2022) Image looking South-West

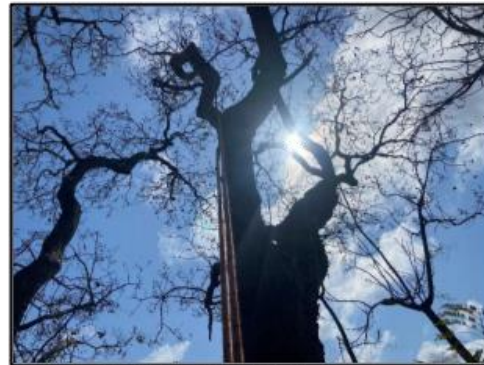
Figure 4 – Subject tree at the time of inspection (20 October 2022) Image taken during the aerial inspection

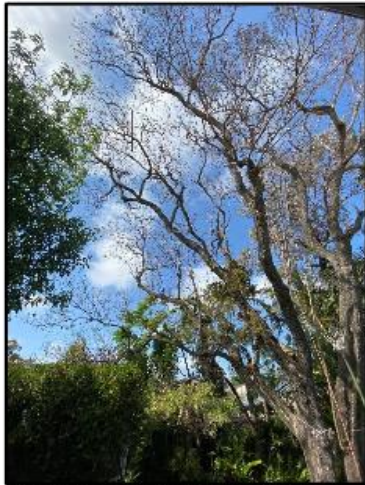
Image taken by Arbor Centre facing South – showing canopy heading toward eastern neighbour

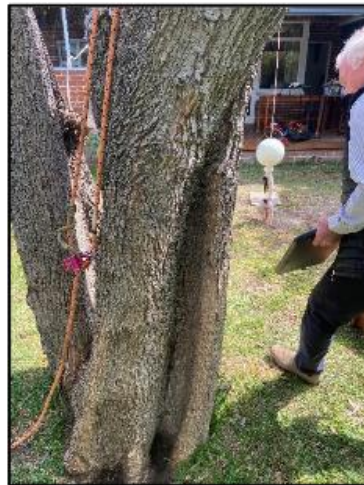
- Tree presents a unique form; the excessive fluting is not a typical characteristic of Jacaranda's. The fluting appears to be in response to previous damage, however, the tree has stabilised well since the damage and still presents solid wood throughout the canopy.
- Inspection of the root flare and first order roots revealed no apparent soil cracks, root plate subsidence, heaving, or noticeable movement at ground level, with good root taper and minor fill noted to the North, East and West sides of the tree (<100mm) however is not considered as a concern at this time.

Image taken by Arbor Centre facing North – showing fluting at ground level

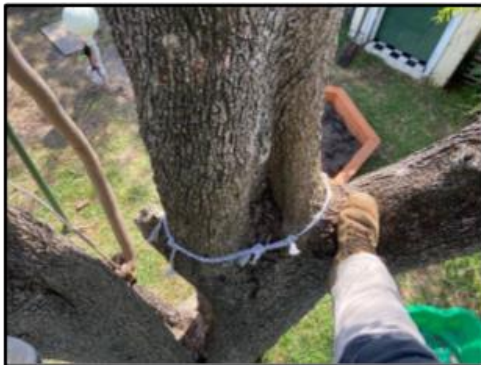
Image taken by Arbor Centre from within canopy – showing fluting within the canopy

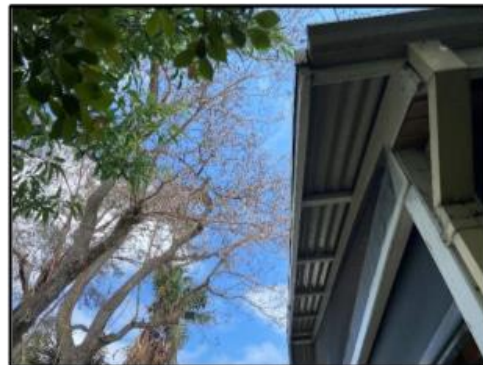
Several structural issues were observed including; previous deleterious pruning (i.e. tree has been lion tailed, however canopy structure could be remediated to offset previous works); stem failures ranging from 50 mm dia. to 150 mm in diameter; deadwood ranging to 50 mm in diameter, minor rubbing and crossing stems to 50mm, however; these issues are generally considered manageable within the scope of an ongoing, proactive tree management, canopy pruning and monitoring program.

Image taken by Arbor Centre facing West – showing failed stem caught in canopy

- That Corrective/Remedial Canopy Pruning be undertaken to address structural defects that were noted in the inspection;
- Aerially inspect the remainder of the canopy for potential structural, health and/or other issues that may not be detectable from ground level.

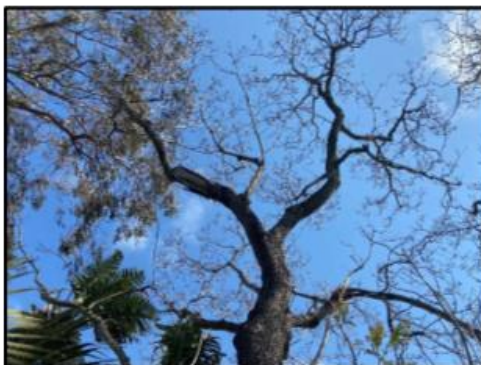
Image taken by Arbor Centre from within canopy – showing wounding from previous failures

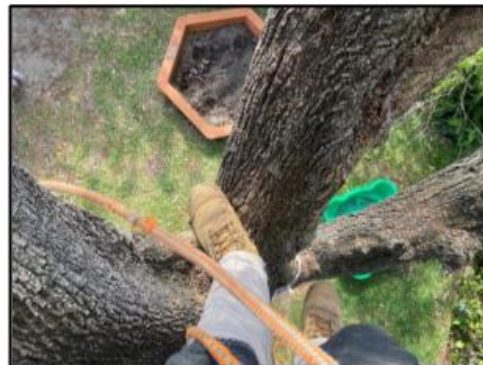
Image taken by Arbor Centre from within canopy – showing sound unions
