## 9.2 AMENDMENT TO THE MUNICIPAL HERITAGE INVENTORY - NO. 40 GUILDFORD ROAD, MOUNT LAWLEY

For Council to consider a request to remove No. 40 Guildford Road, Mount Lawley (the subject site), from the City's Municipal Heritage Inventory (MHI).

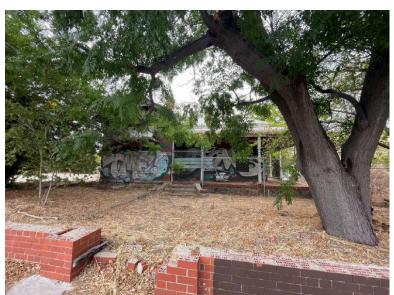
Figure 1: Street Elevation

The subject property has been vacant for a number of years and is currently in a derelict state both internally and externally. The historic fabric of the property has been significantly reduced through vandalism and general deterioration as shown in **Figures 1 and 2** below.

The property is currently in a poor condition as shown in **Figures 1 and 2**. Administration is of the opinion that this degraded state has been caused through neglect and that the dwelling could be restored without impacting its significance.

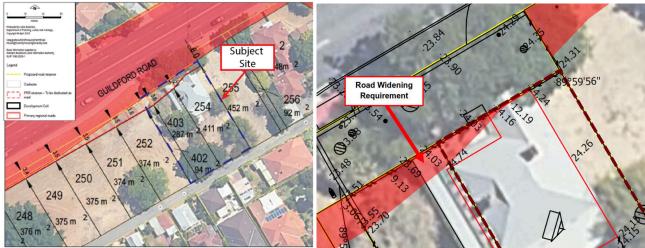
Figures 3 and 4: Primary Regional Road Reservation - Ultimate Land Requirements

MRWA has additional land requirements beyond the existing PRR reserve which will impact the subject site. This is shown in **Figures 3 and 4** below.

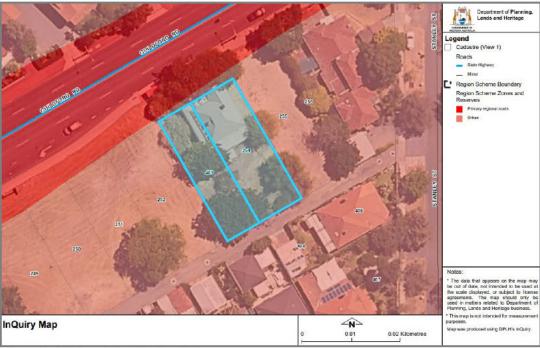
Figure 1 - Metropolitan Region Scheme

Land has previously been excised from the subject lot and set aside for road reserve abutting Guildford Road in preparation of future major capacity upgrades at the intersection of Guildford Road and East Parade. The current MRS reservation delineates additional land requirements for a number of lots along Guildford Road over and above the land which has previously been excised (Figure 1).

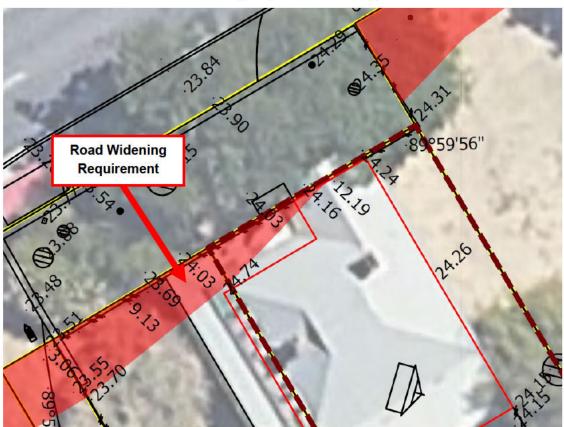
Figure 3 - MRWA Road Widening Overlay

The extent of these required modifications will have a material impact on the fabric of the existing dwelling such that it is considered the original character of the dwelling will be detrimentally impacted and cannot practically be retained. Figure 4 shows an overlay of the endorsed road widening requirements in relation to the surveyed location of the dwelling, highlighting the affected areas.

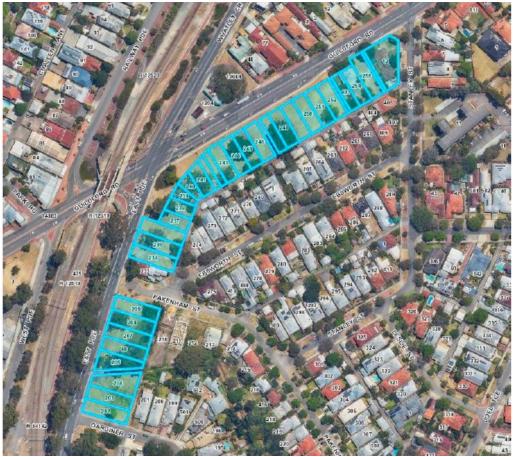
Figure 4 - Landholding for Future Development

Lots 254 and 403 form part of an overall WAPC landholding comprising 34 lots (Mount Lawley HDP site), forming an area of approximately 13,638m<sup>2</sup> located alongside East Parade and Guildford Road, as detailed in the Figure 4 below.

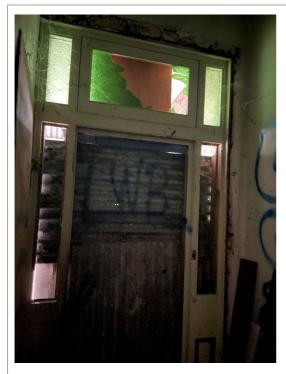
Figure 17: Front Door.

The interior of the property was poorly lit and difficult to navigate because of the removed floorboards and accumulation of debris. The following photographs demonstrate that the majority of detail has been removed. Apart from some original floorboards there are no architraves, skirtings or doors. There is also asbestos sheeting in the rear of the building.

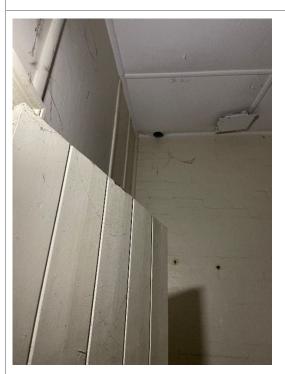
Figure 62: Bathroom door and ceiling.

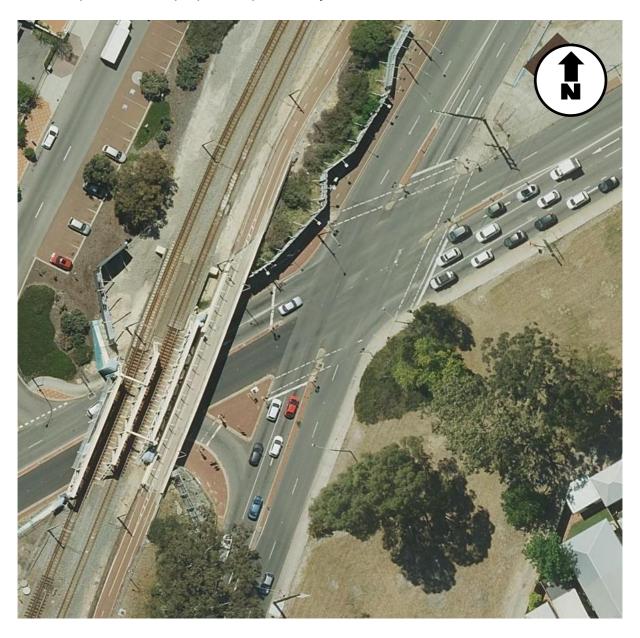
The Project Development branch has requested Road & Traffic Engineering (RTE) to undertake a comparative SIDRA analysis of the existing Guildford Road to East Parade single left turn pocket (shown in Figure 1 below) as compared to the dual left turn pockets in the proposed layout (labelled Option 2a in this report). The intent of this analysis is to assess the optimum length for the left turn pockets in the proposed Option 2a layout at various timeframes.

Figure 1: Guildford Rd & East Parade & Whatley Crescent. Source: ImageNow 2023

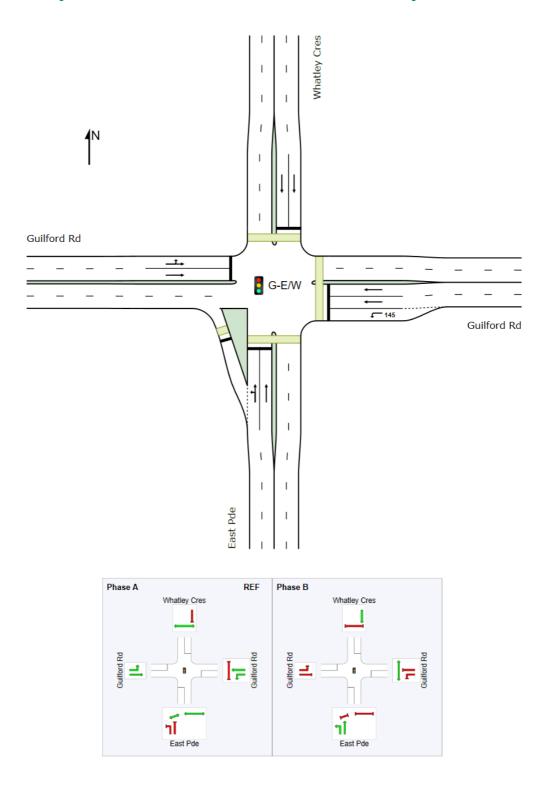
Figure 2: Existing layout and phasing from SIDRA

### 4.1 Model Layout - Guildford Road & East Parade & Whatley Crescent

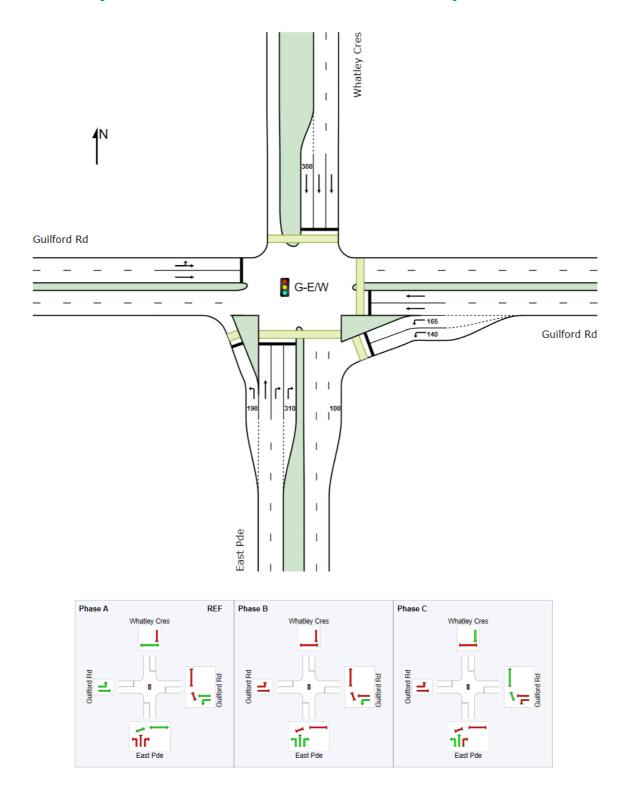
Figure 3: Option 2a layout and phasing from SIDRA

### 5.1 Model Layout – Guildford Road & East Parade & Whatley Crescent
