CONSERVATION PLAN

Lee Hop's Garden (site)

Lee Hop's Cottage

Halvorsen Hall

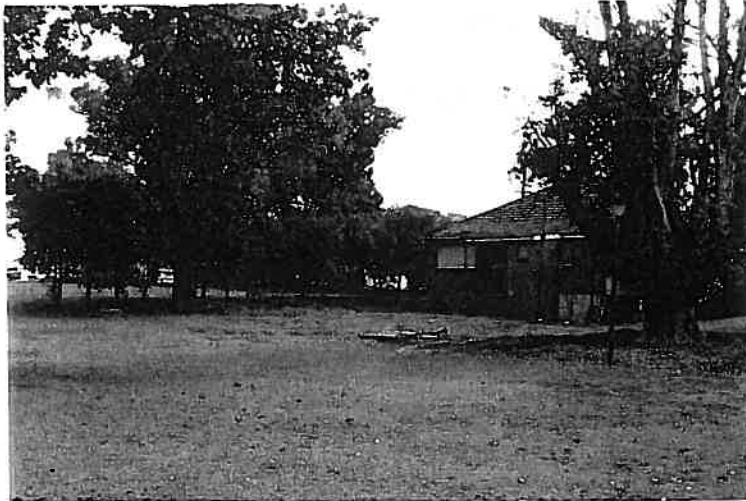
Photograph 4 *Lee Hops Cottage*

Lee Hop's Cottage fronts Fitzgerald Street. There is only a few metres between the edge of the verandah and the public footpath adjacent to the street. (Photograph 3) There are a number of recent 'native' plantings along the street frontage, and an Oleander and Apple Blossom Hibiscus against the north verandah. The area behind the dwelling is bare, with evidence of a hedged plantings along the south western boundary, and remains of the concrete floor of the former laundry and toilet. (Photographs 4 & 5)

View looking west showing the rear area of Lee Hops Cottage.

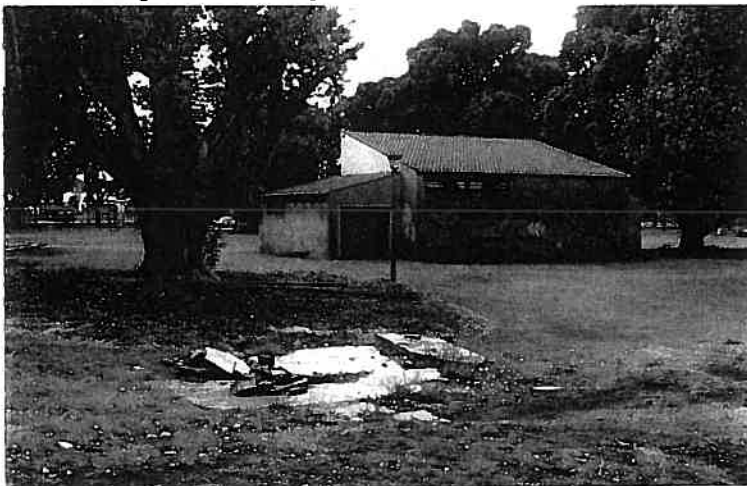
Photograph 5 *Lee Hops Garden (site), Lee Hops Cottage and Halvorsen Hall.*

View looking north east showing the remains of the laundry and toilet at rear of Lee Hops Cottage.

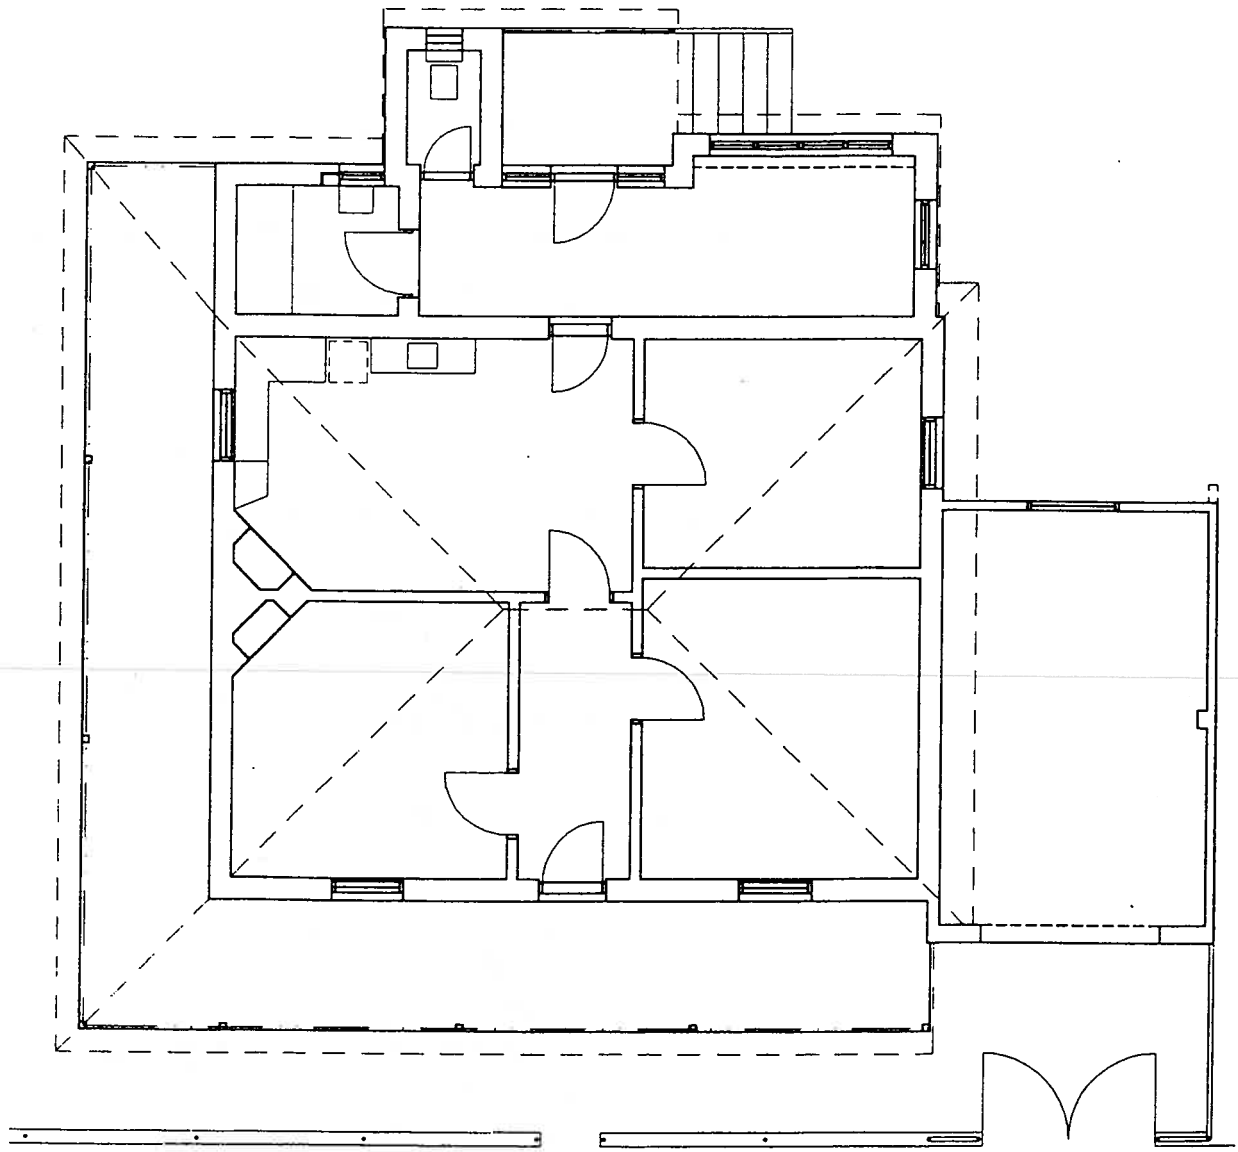
PLAN 9 c. 1998 Lee Hops Cottage measured drawings Floorplan

Layout	The dwelling is square in plan, comprising four main rooms and a central hall at the front. There is an open front and north side verandah and an enclosed verandah across the rear, with a garage extension on the south side.
Structure	<p>The original 1903 construction is brick on a limestone foundation. The front and side verandah are timber constructions on timber stumps, and the rear extension and garage are brick on a brick foundations. (Photograph 10)</p> <p><i>Condition</i> From a visual inspection, the building appears to be structurally sound, although there is subsidence of the side verandah where a post has been partially removed, and other posts have subsided along the front and north side. (Photograph 11) The limestone wall in the north east corner shows signs of erosion and fretting mortar. (Photograph 12)</p>
Roof	The 35 degree hipped roof is clad with Brisbane and Wunderlich clay tiles, fixed with wire. (Photographs 9, 13) The main roof breaks pitch to cover the verandas on the front and side, and forms a skillion at the rear. Evidence of the original separate verandah roof at the front is shown by the remaining bearer beams across the front wall. (Photograph 14) The brick corbelled chimney has been painted. (Photograph 15) A skylight has been installed in the kitchen roof. The garage has a metal deck skillion roof.

FLOOR PLAN scale 1:100

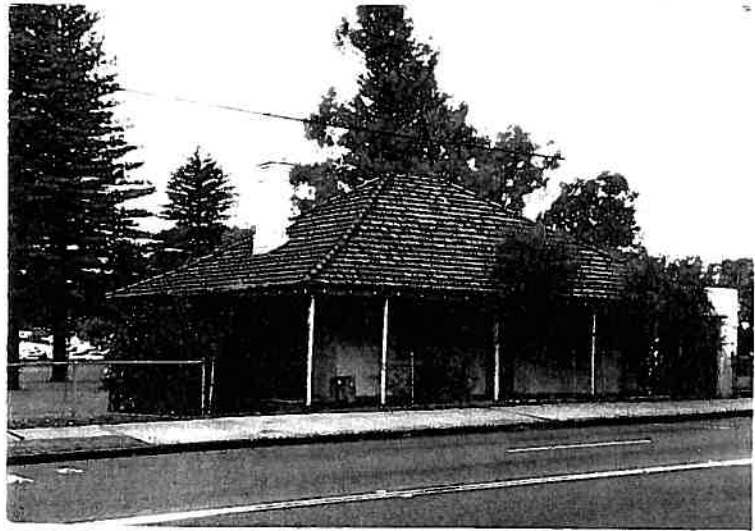
Photograph 9 *Lee Hop's Cottage*
Fitzgerald Street frontage (northwest).

Current Use	Plans 9-11. Photographs 9-38. Vacant dwelling.
Original Use	Dwelling.
Associations	Lee Hop (1903-1914), Robertson Park caretakers (1928-1992).
Architectural Description	<p>The one storey building has a symmetrical frontage, with a simple hipped roof. (Photograph 9) The tiled roof extending over the verandahs replaced the original corrugated iron roof with separate skillion front and rear verandah. The verandah enclosure across the rear, and the garage on the west side are later additions.</p> <p><i>Lee Hop's Cottage</i> displays some characteristics of the 'Victorian Georgian c.1840-c.1890' architectural style as described in 'Identifying Australian Architecture.'⁷³ (Appendix) Typical of the style, the building has simple rectangular form, symmetrical facade, unsophisticated details, sash windows, and an original separate verandah roof.</p>
Development	<p>1903 Dwelling</p> <p>1928 Side verandah (north) Brick wash house and WC Tuck pointing to front & side walls Fence</p> <p>1954 Brick garage</p> <p>1955 Restructure the roof and replace corrugated iron with tiles.</p> <p>1956 Lathe & plaster ceilings in two front rooms & hall removed. Electrical rewiring</p> <p>1958 Bathroom renovated.</p> <p>1963 Room at south west end of rear verandah</p> <p>c.1970 Kitchen fitout</p> <p>1975 Rear verandah and toilet</p>

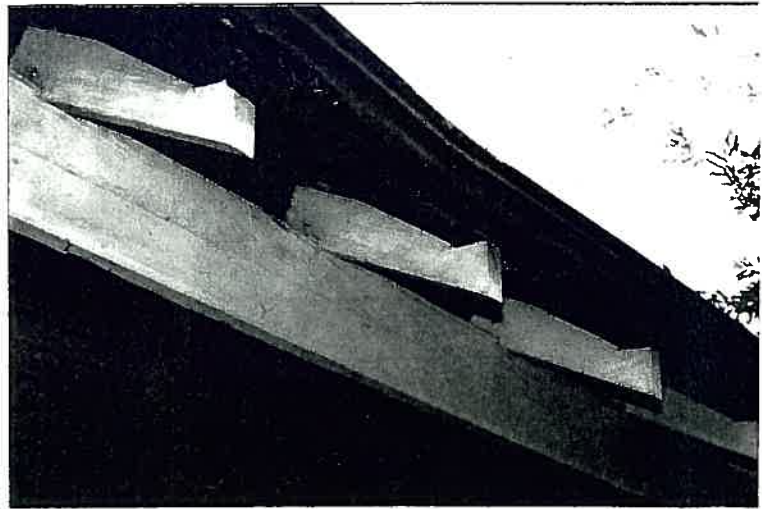
Photograph 16 *Lee Hop's Cottage*
Front gutter.

- Condition* The gutters are rusted and full of debris. (Photograph 16) They are in very poor condition. There is no provision for drainage from the downpipe outlets and away from the perimeter of the building.

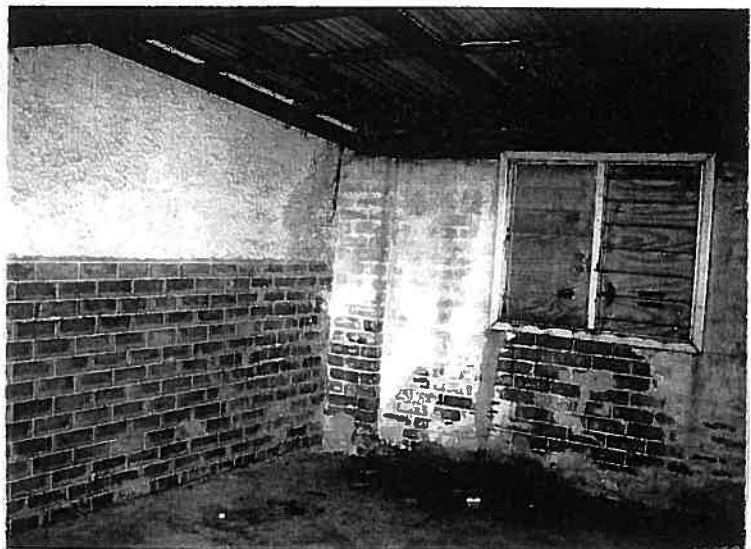
Photograph 20 *Lee Hop's Cottage*
Garage interior showing cottage wall and deterioration of the garage wall.

- Windows** The original double hung sash windows on concrete sills are still in place in each of the four main rooms. Metal security mesh has been fitted to the exterior of the windows, and most of the glazing is broken. (Photograph 31) The windows on the rear verandah area have been boarded over with wire mesh and boards on the inside and sheets of corrugated iron on the exterior. (Photographs 32, 33) Similarly the garage louvred windows have been boarded over. (Photograph 20)

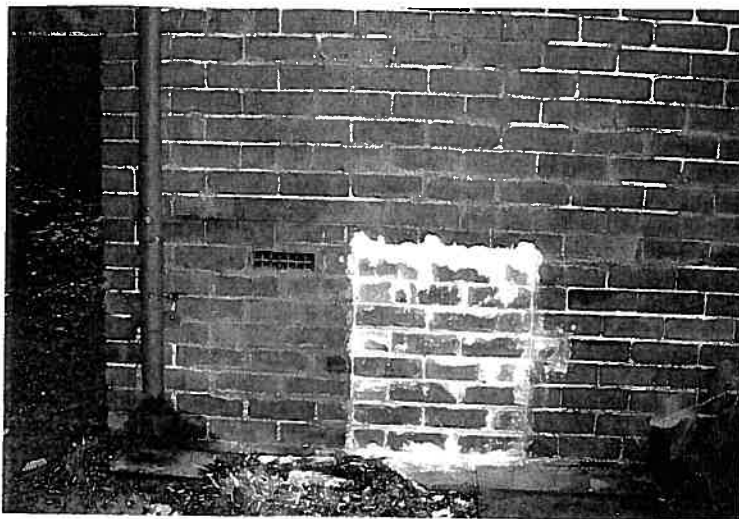
Photograph 22 *Lee Hop's Cottage*
Rear repairs to 1975 brick wall.

- Condition* The original walls are in good condition, although the north wall has been stained by bore water. The garage walls show evidence of fretting mortar and brick deterioration, and there is graffiti on the south wall. (Photographs 20, 21) The rear verandah brickwork shows evidence of previous repairs to the mortar. (Photograph 22)

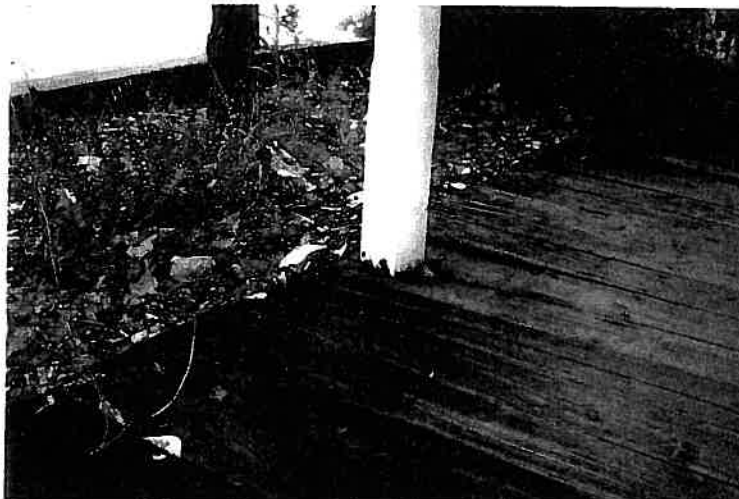
Photograph 23 *Lee Hop's Cottage*
Front verandah subsidence.

- Condition* The floors of the dwelling appear to be sound. The timber verandah floors are in poor condition. The verandah floors have subsided in the vicinity of the posts along the front and north side (Photographs 18, 23) and it is in a dangerous condition where the boards are missing along the north side (Photographs 18, 24), and where the boards are buckled (Photograph 23). There is no obvious evidence of termite activity.

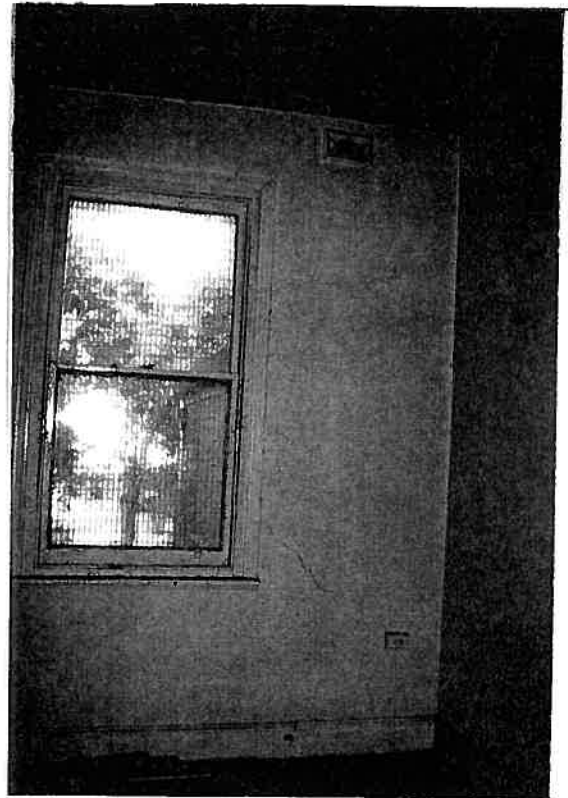
Photograph 29 *Lee Hop's Cottage*
Rear bedroom (south west) wall cracks.

- Condition* The walls are in fair condition. There is some cracking on the south wall. (Photograph 29) The kitchen and rear bedroom walls are smoke damaged. The rear verandah walls have been damaged by fire and smoke. (Photograph 30)

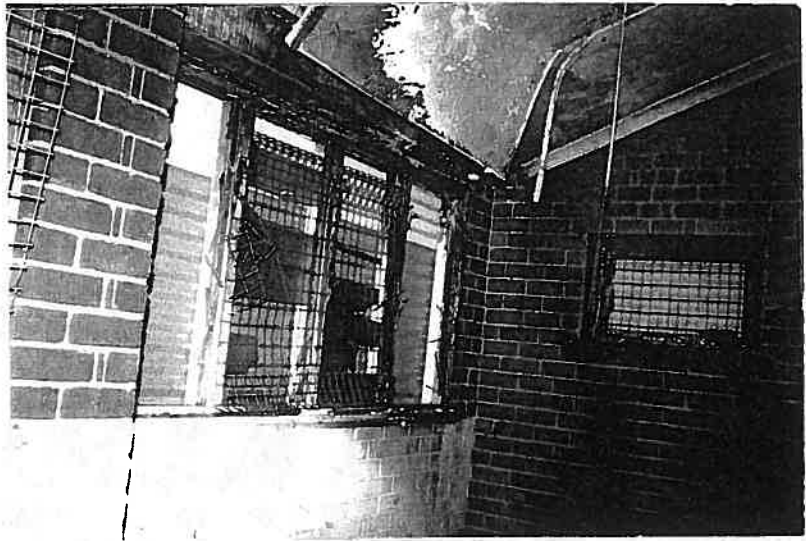
Photograph 30 *Lee Hop's Cottage*
Fire and smoke damage to rear verandah.

- Condition* The ceilings in the dwelling are in fair to good condition. The kitchen and rear bedroom ceilings are smoke damaged. The ceiling in the rear verandah is fire damaged and in a dangerous condition. (Photograph 30)

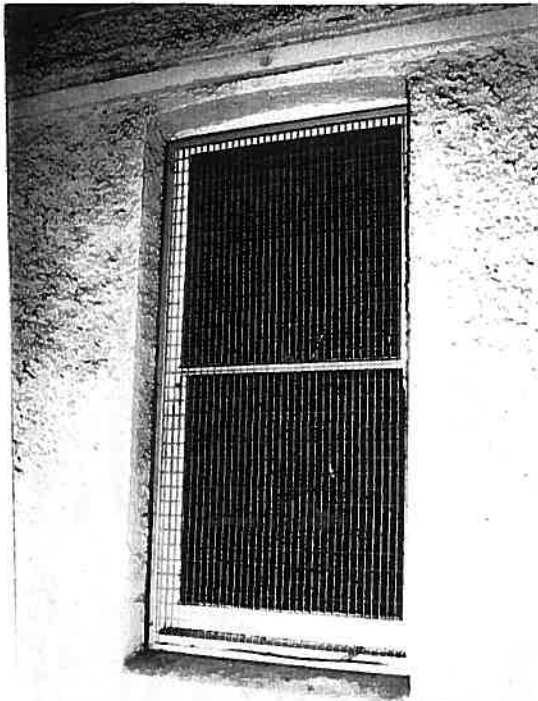
Photograph 31 *Lee Hop's Cottage*
Front window. (typical).

- Condition* The original windows frames and sashes are in fair to good condition. The other windows are in very poor condition. All the glazing is broken.

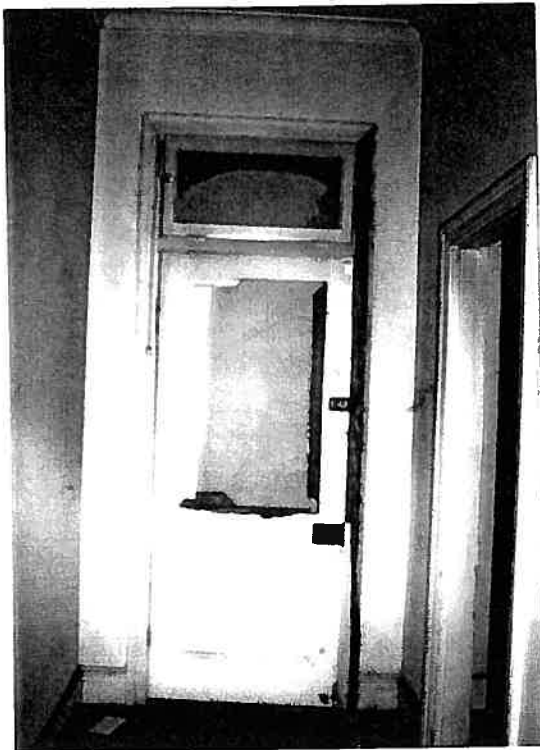
Photograph 34 *Lee Hop's Cottage*
Original front door remains but is damaged.

- Doors** The only remaining original door is the front door, although it is damaged. The door and the skylight above have been boarded over. (Photograph 34) The doors to the other rooms have been removed.

- Condition* The front door is in poor condition.
- Fixtures & Fittings** The architraves and skirtings are still in place in the four main rooms and the hall. (Photograph 35) The back to back fireplaces in the kitchen and front room are still in place. There is no mantle or fire surround in the front room. The kitchen still has the original Metters No 1. stove although the surrounds have been altered. (Photograph 36) The c.1970 kitchen fitout and cupboards from an earlier period are in place. (Photograph 37) The bathroom has a c.1950s built in bath, small sink and wall cupboard.

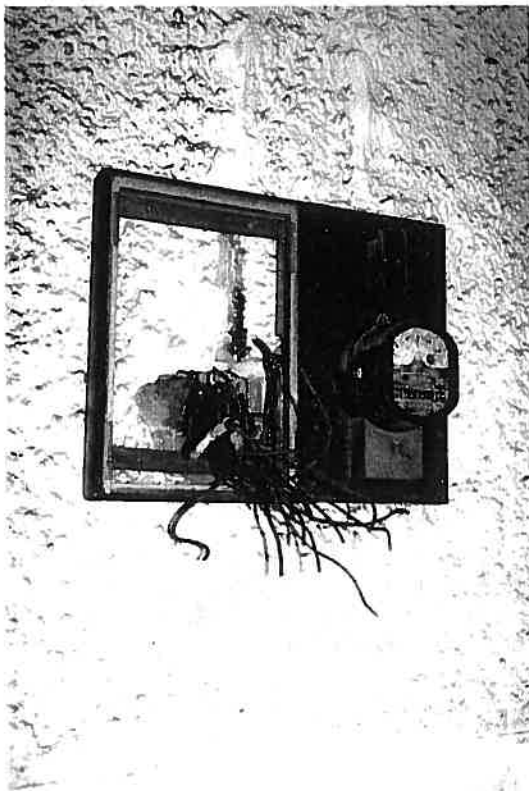
Photograph 38 *Lee Hop's Cottage*
Electrical meter box on the front wall.

- Services** The power has been disconnected and the wiring appears to be in a dangerous condition. (Photograph 38) Water and sewer services are connected.

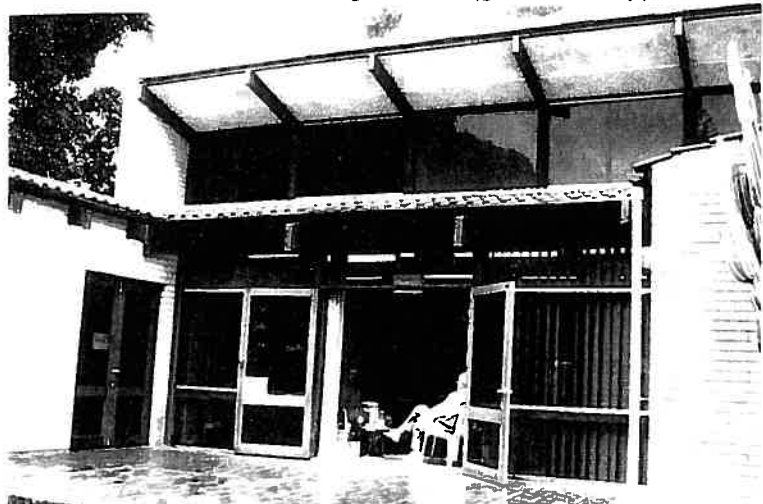
Photograph 41 *Halvorsen Hall*
Clerestory windows on north east frontage.

Doors	<p>The main entry doors, to the north east, and south west corner, are glazed doors in varnished timber frames. (Photographs 41 & 46) Internal and external toilet doors are flush panel. Door frames and architraves throughout are varnished. A colorbond roller door provides access to the garden store on the western corner.</p> <p><i>Condition</i> Generally, the doors are in fair condition. The north east court doors a show evidence of moisture ingress and rot, as well as the varnish weathering. (Photograph 55) The external ablution flush panel doors are badly weathered. (Photograph 49)</p>
Fixtures & Fittings	<p>The kitchen and toilet fitouts are basic. Ceiling fans and fluorescent lighting are suspended from the ceiling structure, electric heaters are fixed to the walls. Light switches are located in the meter box in the foyer. Vertical blinds are fitted to the north west court windows.</p> <p><i>Condition</i> The kitchen and bathroom fitouts are serviceable.</p>

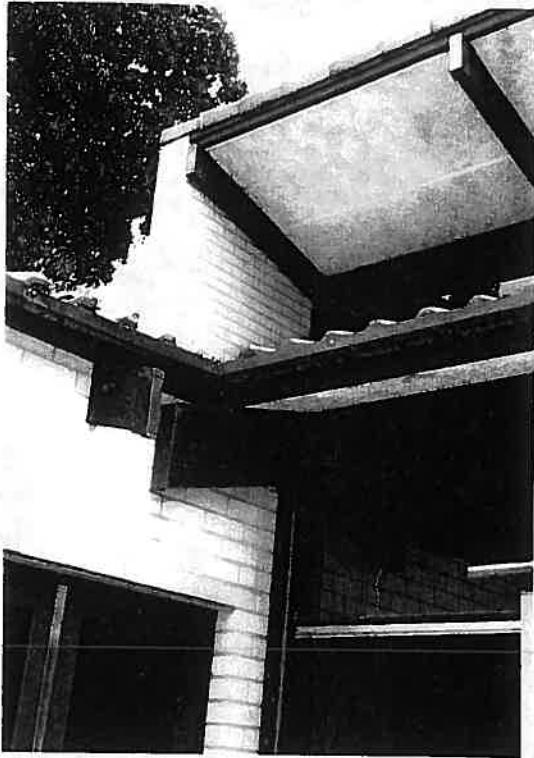
Photograph 42 *Halvorsen Hall*
Roof and rafter detail (north east)

Drainage	<p>The original flat rectangular copper gutters are still in place around the court, (Photograph 42) but have been removed from the other sides of the building. (Photograph 43) Two round PVC downpipes are connected to a drainage system. (Photograph 40)</p> <p><i>Condition</i> The gutters are dented in some places, but generally in a fair to good condition.</p>

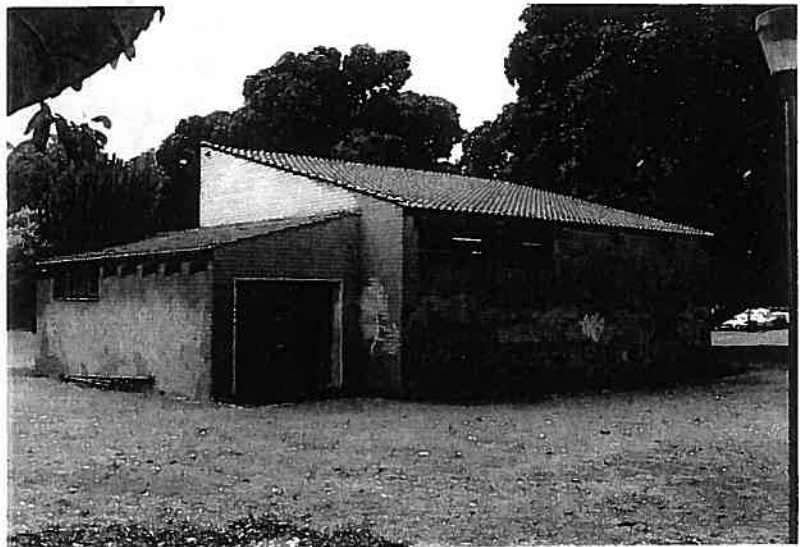
Photograph 44 *Halvorsen Hall*
North west walls.

Exterior walls	<p>The original external walls are light cream coloured face brick.</p> <p><i>Condition</i> The walls show extensive evidence of graffiti and graffiti removal, and stains from the park watering system. (Photographs 44, 45 & 46) In several areas, the face of the brick has been damaged by the chemicals used in the graffiti removal process. (Photograph 47)</p>
Floors	<p>The floor is 0.75 tongue and groove timber boards finished with a gloss epoxy sealant, throughout the interior of the hall. An area of the floor up to 1.5 metres inside the north east opening appears to have been replaced. The ablution area and kitchen have concrete floors with ceramic tiles over. The external court area is brick paved (Photograph 48), as is the entry platform in the south corner (Photograph 46), and on the south east side. (Photograph 49)</p> <p><i>Condition</i> The timber floors are in relatively good condition. There is no evidence of termite or other damage, but considerable surface scratches. The paved areas similarly are in good condition, although dangerous when wet and with leaf debris. (Photograph 49)</p>

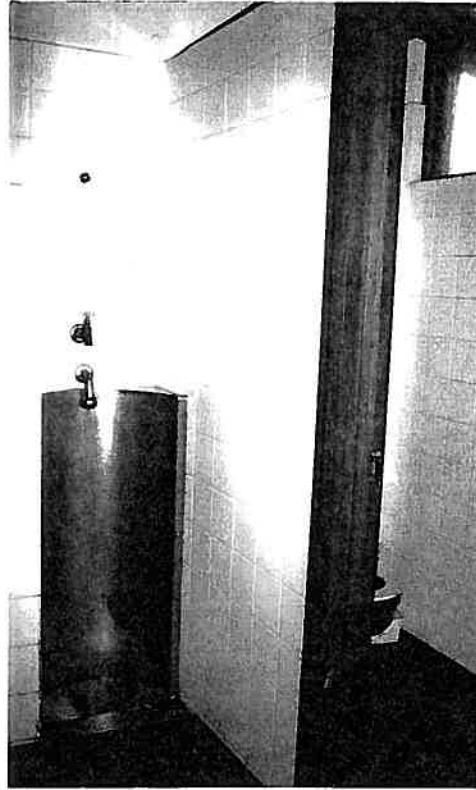
Photograph 52 *Halvorsen Hall*
Mens Toilet.

Interior walls	<p>The interior walls of the main hall and storeroom are unpainted face brick. (Photograph 50) The kitchen and ablution areas are finished in hard plaster with ceramic tiles. (Photographs 51, 52)</p> <p><i>Condition</i> The walls are in good condition.</p>
Ceilings	<p>The ceilings in the main hall and kitchen are lined on the rake with fibrous acoustic panels and exposed painted timber rafters. (Photograph 53) The ablution areas have flat ceilings lined with plasterboard.</p> <p><i>Condition</i> The ceilings are in fair to good condition. There is staining, which may be evidence of moisture damage, to the panels along the north east wall, above the opening. (Photograph 54)</p>
Windows	<p>The windows are timber framed. The windows high on the north west wall have aluminium sashes. The windows on the north east court frontage have sashless sliding glass in aluminium sliding tracks. The clerestory windows are fixed, and similarly timber framed. (Photograph 54)</p> <p><i>Condition</i> Windows frames and sashes are fair to good. The external timber frame work on the north east windows is weathered.</p>
