CITY OF VINCENT

HERITAGE ASSESSMENT

Address: Nos. 68-70 Cowle Street, West Perth				
Precinct: N/A		Place Name: N/A		
Folio: 17	Lot: 41	D/P: 46440	Vol. 1375	Land Use: House

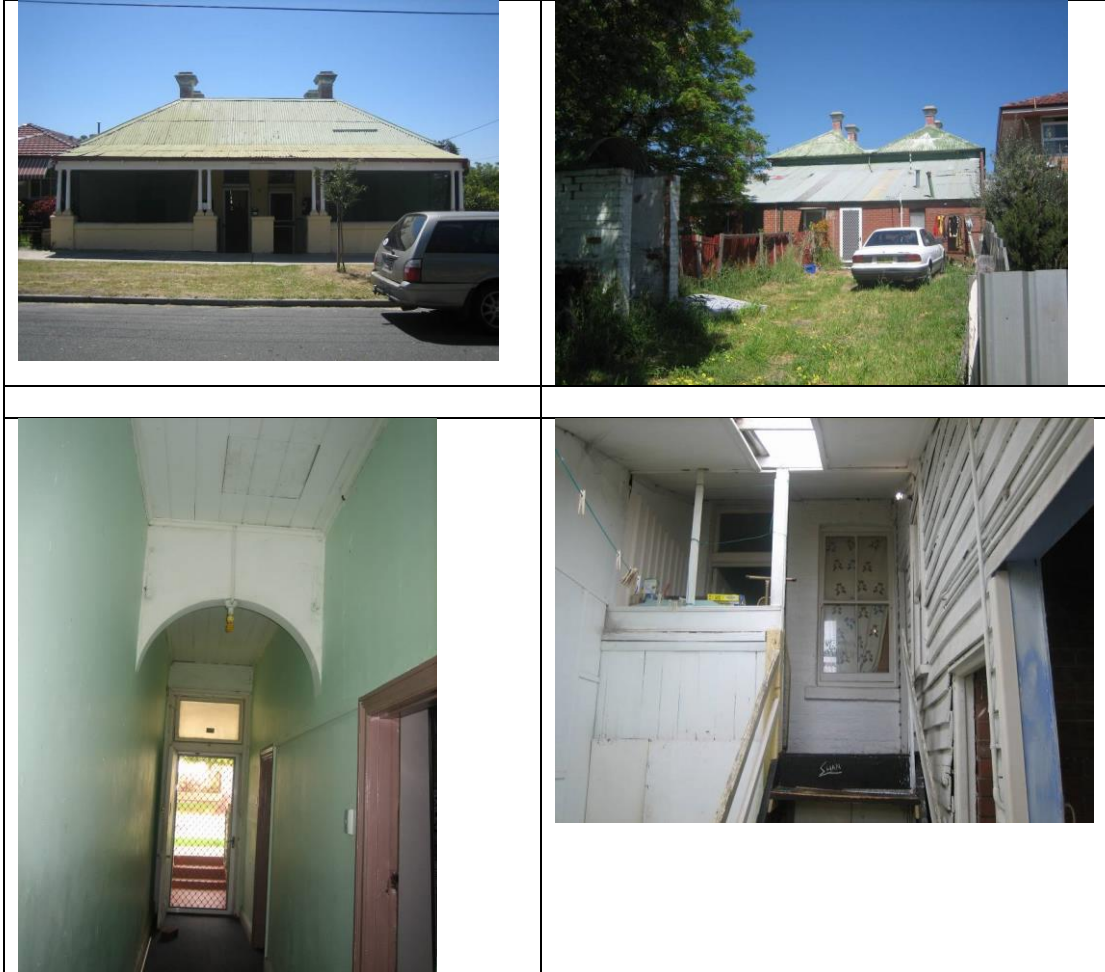
Before fire damage (photographs taken on 29 September 2006)

Before the fire damage, the dwellings consisted a mirrored pair, which had symmetrical façades. The front doors were located in the centre of the façade, next to the party wall. A sash window was located on each side of the dwelling.

The dwelling was constructed from rendered brick and corrugated iron which has been painted green. The façade had been painted a cream colour and grooves had been etched into the render to give the appearance of large blocks. The corrugated iron sheeting on the roof and verandah was in short sheets. The roof extends to form a skillion front verandah which was supported by sets of two slender classical columns, mounted on piers located at the middle and ends of the verandah. A rendered balustrade ran along the front of the dwelling, between the piers and was situated on the front boundary. Another balustrade separated the front of the two dwellings and ended in a pier on the property boundary.

Each side of the pair had two chimneys with corbelled tops. At the rear of the dwellings was a weatherboard skillion roof extension.³

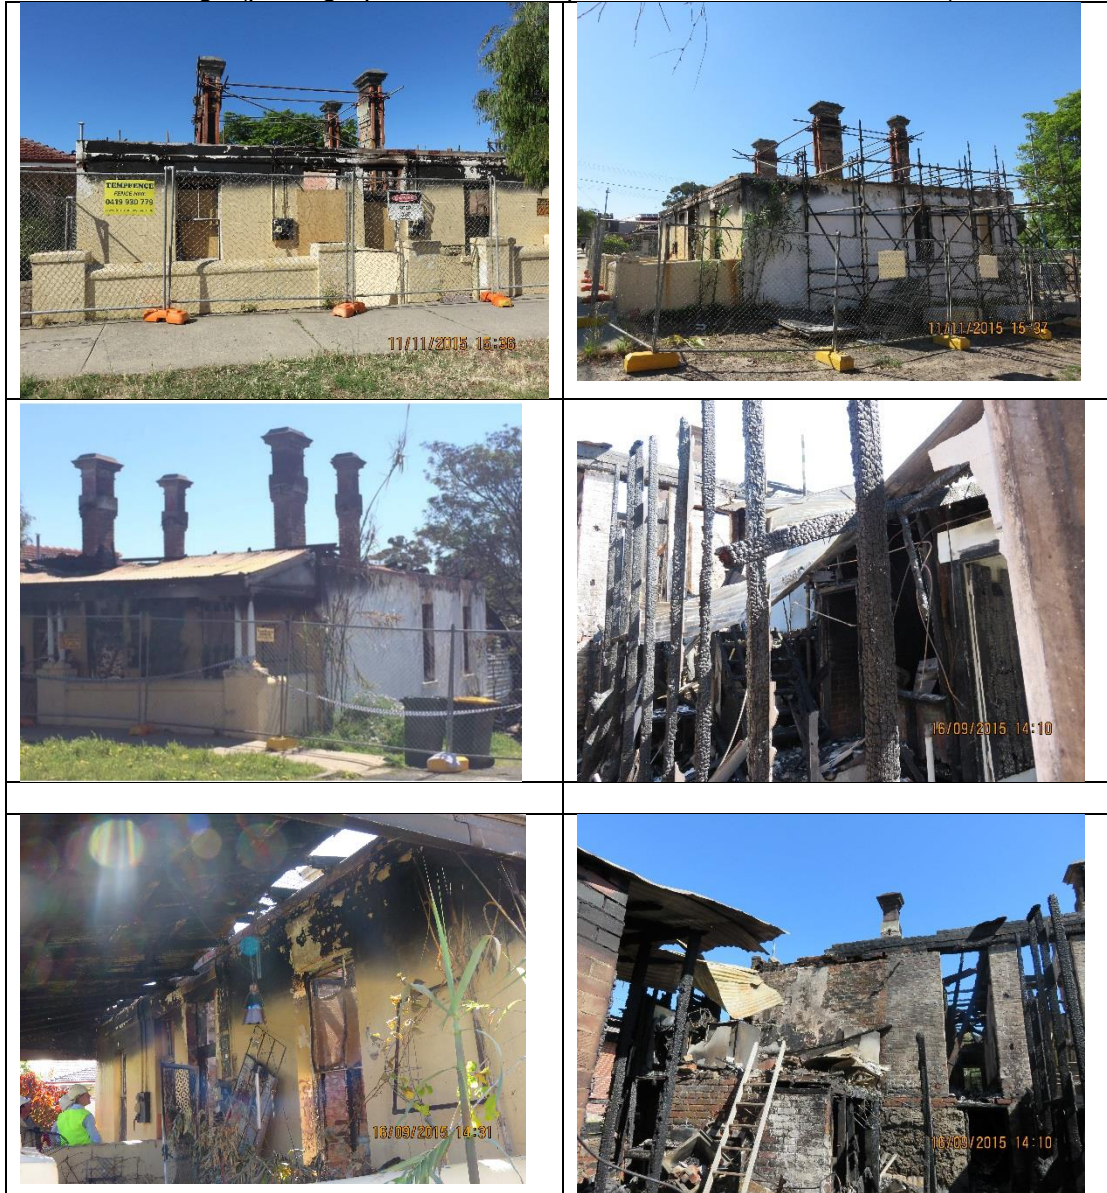
After fire damage (photographs taken in September and November 2015)

The subject place was damaged as a result of a fire on 13 September 2015. A Structural Inspection Report conducted by Wood & Grieve Engineers indicates that the residual structural integrity of the fire-damaged components has been sufficiently compromised to consider complete demolition.⁴

- Extensive damage is evident throughout generally.
- The timber roof has been completely destroyed as a result of the fire and remaining timber members are largely charred and/or missing.

- The loss of timber roof members has removed all lateral restraint to the free-standing masonry walls. As a result, the stability of most walls have been compromised and there is a risk of collapse of existing masonry walls in some areas in the current condition.

- Cracking to existing walls was apparent in a number of locations. This is likely to have been caused by lateral wall movement and subsidence.
- The sub-floor structure appears to have been extensively damaged in a number of areas.

- The majority the timber lintels have been irreparably damaged. Tell-tales signs of masonry distress such as cracking and sagging are evident in some area as a result. These areas are at risk of further damage and/or collapse.

- Extensive render damage is evident throughout generally and little remains of existing timber window and door frames.
- Extensive temporary stabilisation work would be required to safe-guard the existing walls against potential collapse prior to occupying adjoining properties and allowing access to site.

The Structural Inspection Report concludes, *'There appears to be limited opportunity for salvaging a number of key structural (and possibly heritage) components (including chimney, the rear wall of the dwellings and front verandas all of which would require full or partial demolition) and the complexity of the temporary works required to adequately stabilise the structure for the safety of adjoining buildings and public footpaths presents additional risk, which can only be completely eliminated if full demolition is considered as an option.'*

Given the above, Administration supports the deletion of Nos. 68-70 Cowle Street from the Municipal Heritage Inventory.
