**9.4 RESPONSE TO PETITION RELATING TO ODOUR FROM 7 GRAMS CHICKEN, NOS. 212-214 LAKE STREET, PERTH**

## **Food business odour complaints 212 - 214 Lake Street, Perth**

### **Odour impact verification and possible mitigation**

**Project:** Food business odour complaints  
212-214 Lake Street, Perth

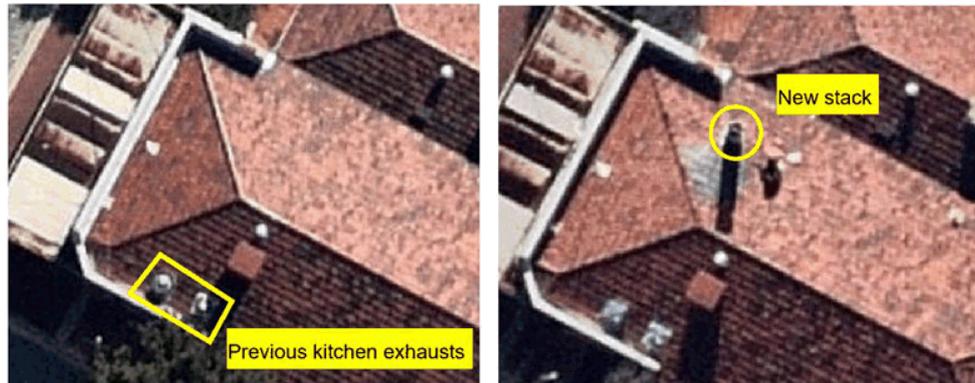
**Figure 1:** Former and new fume exhausts from the restaurant

**Figure 1** presents the previous location of the kitchen exhausts and the new stack.

Initial exhausts of the cooking were located on the southern side of the building and were less than a meter high (left aerial photo on **Figure 1**).

When odour complaints started occurring, it was identified that emissions at a higher level may be necessary to create more dispersion of the plume. The two kitchen exhausts were plugged. The extraction network was re-designed to direct the exhaust fumes towards a new stack located on the northern side of the roof.

The stack height is 3.2m from the roof level, with a cross section at the tip of 450mmx450mm in size. The velocity of the exhaust air at the outlet of the stack is 10 m/s.

The stack is 3.2m above the roof level and its tip is at 6.5m from ground level, but less than 1m above the apex of the restaurant's roof. This means that the plume will be subject to a downwash effect for any wind direction. To avoid the downwash effect of the plume, it is generally recommended to increase the height of the stack and/or change the location of the stack on the roof.

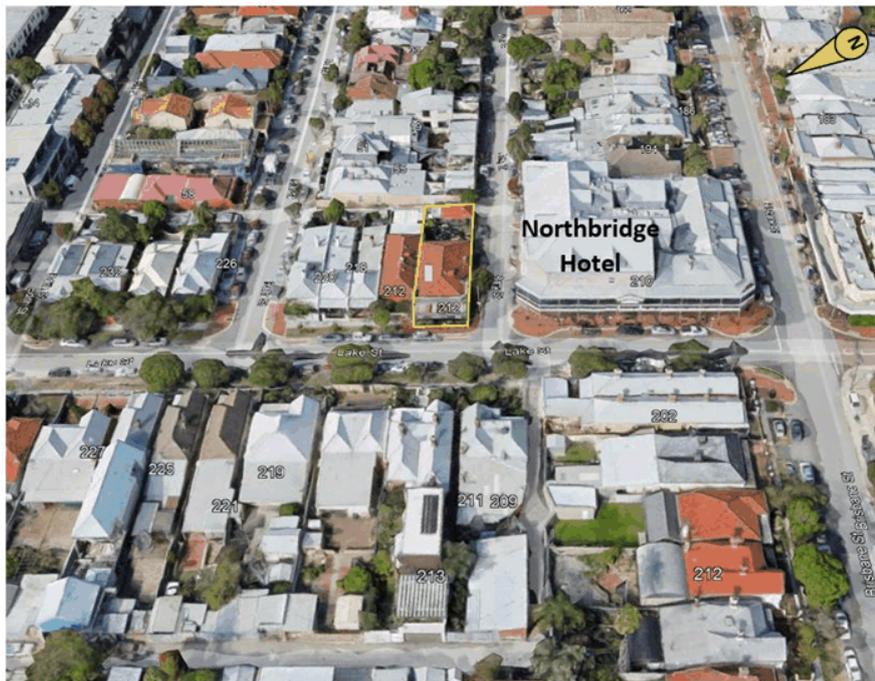
Figure 2: Vicinity of the restaurant

The restaurant is located within a residential area at the corner of Amy Street and Lake Street. **Figure 2** presents a 3D view of the residential area with the restaurant outlined in yellow.

The restaurant is a one-storey building that shares a wall with a town house on the northern side.

Most of the surrounding residential houses are only one-storey buildings of similar height than the restaurant building.

However, the Northbridge hotel is a much larger and taller building located to the south of the restaurant across Amy Street.

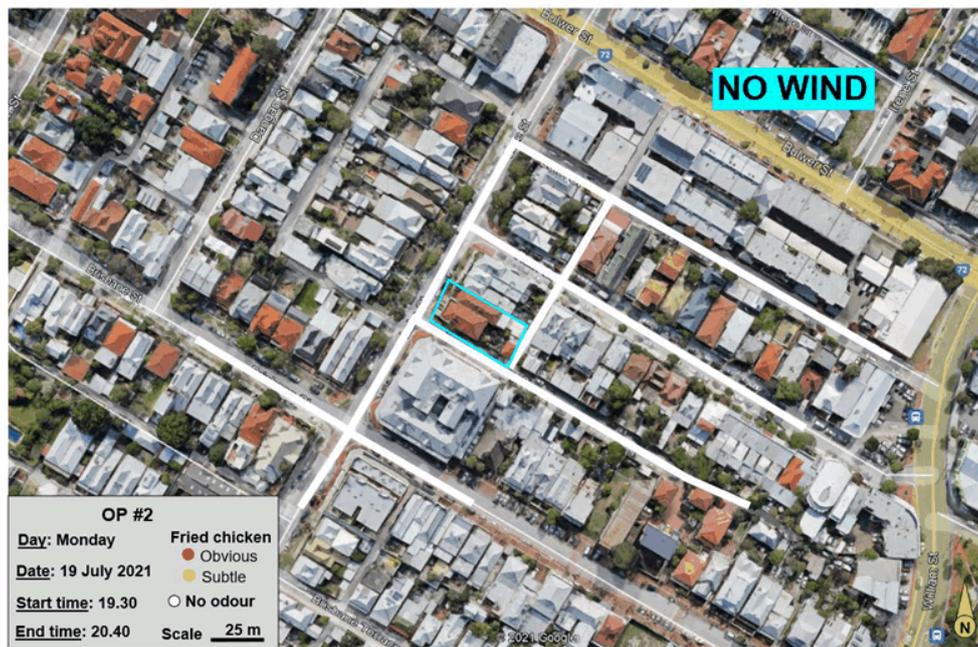
**Figure 4: Odour impacts on Monday 19 July 2021 – 19.30 to 20.40**

With no wind during the assessment, no odour could be recognised in the streets within a 160m radius. The white lines in Figure 2 indicate the path that was patrolled with no odour recognised.

This demonstrates that the plume rises with enough momentum to disperse without any ground level impacts when there is no or very light wind.

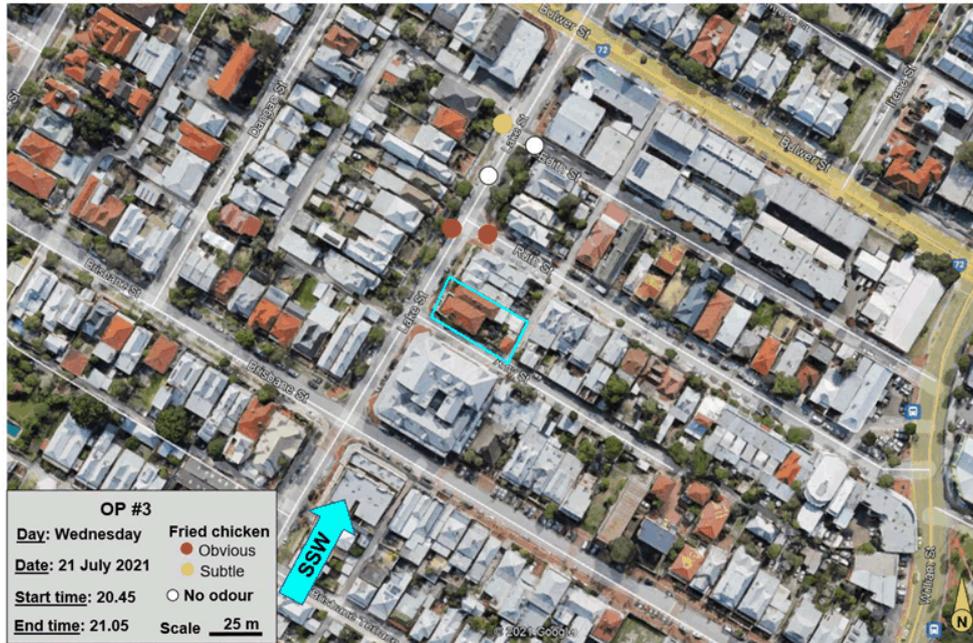
Figure 5: Odour impacts on Wednesday 21 July 2021 – 20.45 to 21.05

The wind was very light with velocities below 1 m/s at ground level. BoM wind conditions indicated a SSW wind of about 7km/h (about 1.5 m/s).

Under such light wind, an obvious odour was recognised close to the restaurant and subtle odours could be recognised at a distance up to 80m from the restaurant building.

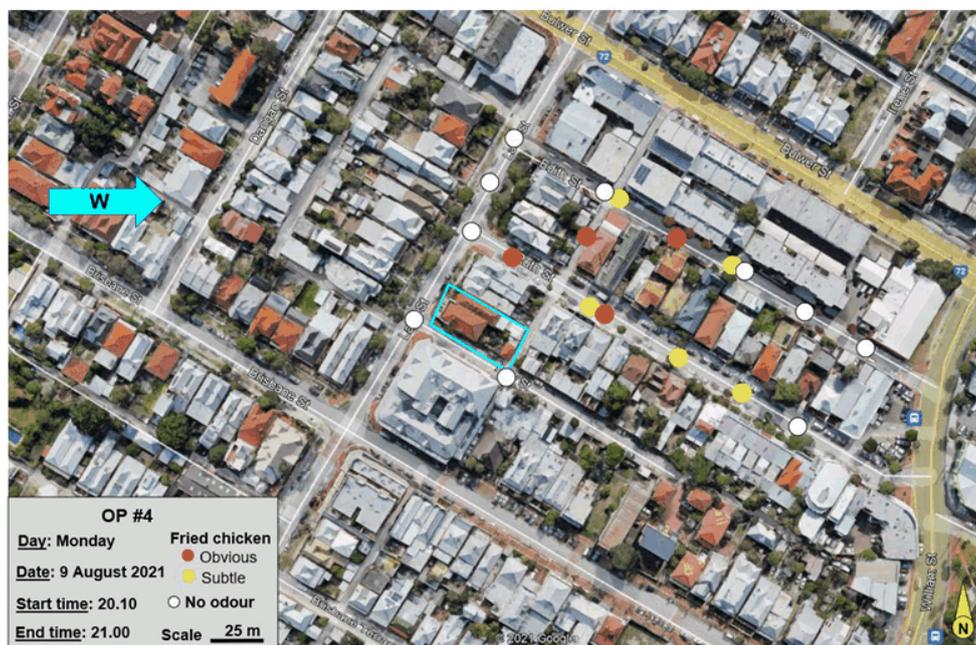
Figure 6: Odour impacts on Monday 9 August 2021 – 20.10 to 21.00

An obvious odour from the restaurant could be recognised at a distance up to 100m from the restaurant’s stack, and a subtle odour at a distance up to 140m.

Under this wind velocity, the wind cavity that developed over the restaurant likely dragged the plume emitted at the stack, and then cascaded down into Ruth Street and Edith Street. Therefore, limited dilution occurred and odour from the restaurant could be recognised at obvious and subtle levels in this area.

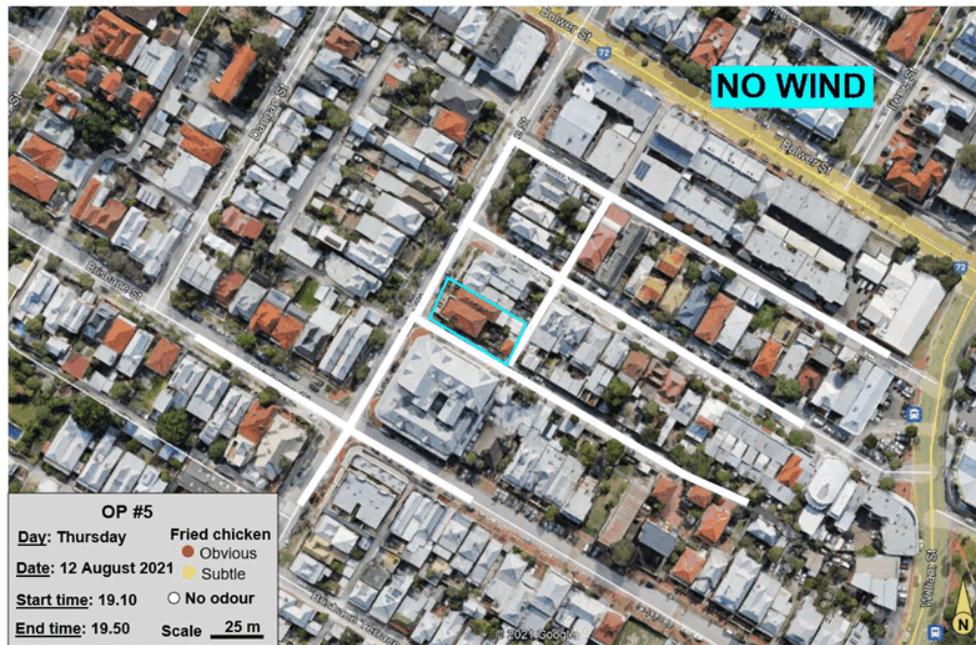
Figure 7: Odour impacts on Thursday 12 August 2021 – 19.10 to 19.50

There was barely any wind on site. Wind data in **Table 2** indicates no wind for the duration of this OP.

The same path as OP #2 was patrolled with the same results, i.e. no odour was recognised. With no wind during the assessment, no odour could be recognised in the surrounding streets within a 160m radius.

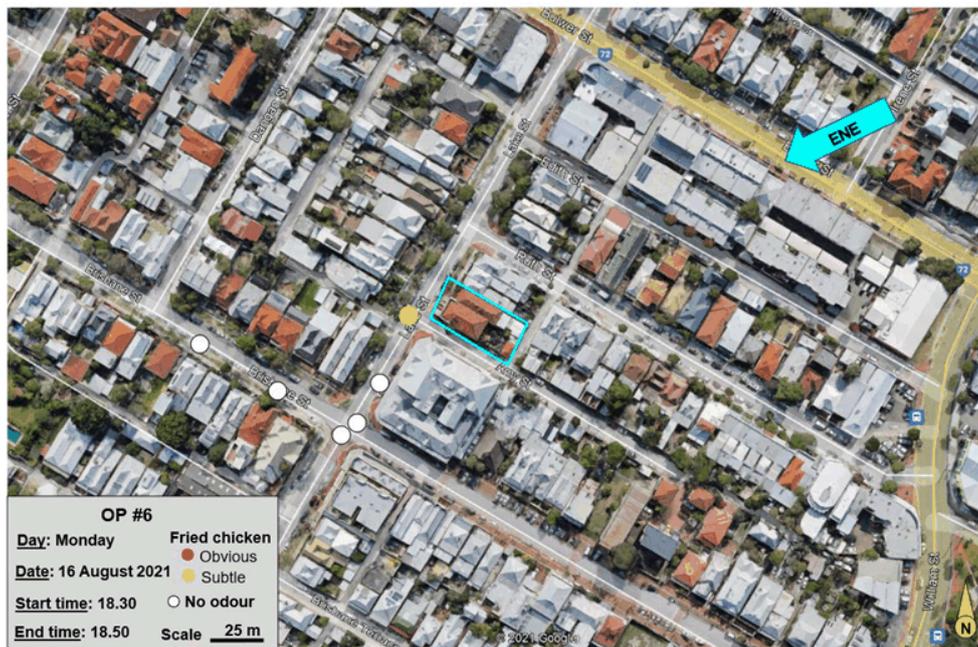
**Figure 8:** Odour impacts on Monday 16 August 2021 – 18.30 to 18.50

The wind was very light (maximum 1 m/s) from a NE direction recorded at ground level during this OP. The wind data from the BoM showed a general ENE direction and velocities between 4 and 9 km/h (i.e. 1 – 2.5 m/s).

With little to no wind, there was only one location with subtle odour from the restaurant recognised. The possible downwash effect was likely limited during this OP due to the low wind speed.

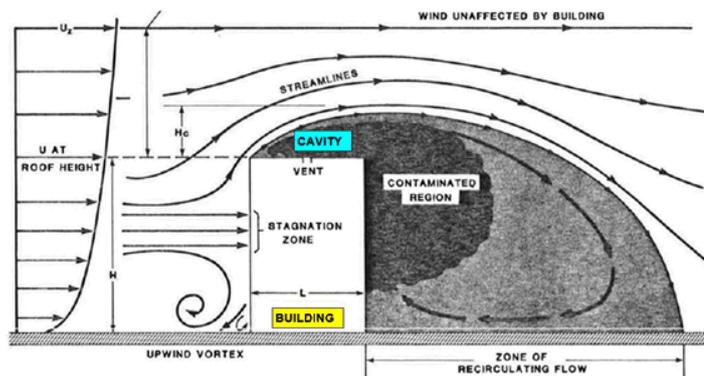
**Figure 9:** Downwash effect when wind impacts a building

**Figure 9** presents a drawing that provides a visualisation of the wind streamlines above a building hit by the wind. A cavity is formed at the top of the building before going down at the back of the building (building wake).

Fig. 1 Centerline Flow Patterns Around Rectangular Building<sup>1,2</sup>

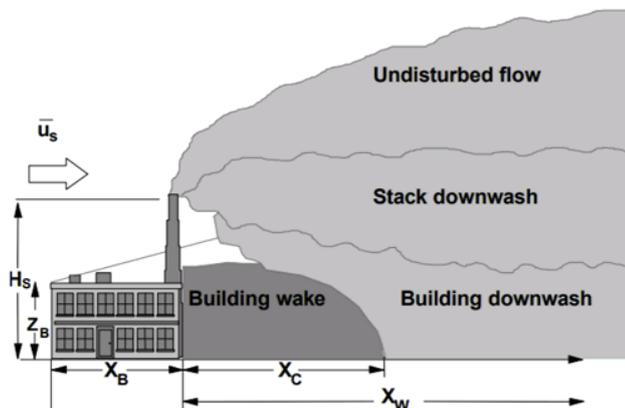
**Figure 10:** Stack and building downwash effect

When a stack is installed on the roof of a building, stack downwash and building downwash occur downstream when they are hit by wind. An illustration of this phenomenon is provided in **Figure 10**.

**Figure 10** illustrates what happens to emissions from the restaurant under westerly (W), northerly (N), and easterly (E) winds. The cavity is built at the level of the restaurant's roof or other surrounding residents' roofs. Then, the building wake (or zone of recirculating flow) takes place on either Amy Street (N wind), Lake Street (E wind) or Ruth Street (W wind). Once at ground level, any street, lane, and gaps between buildings will provide preferential pathways. This phenomenon is called the canyon effect and will transport the plume further away and possibly at an odour concentration level that can be recognised by residents.

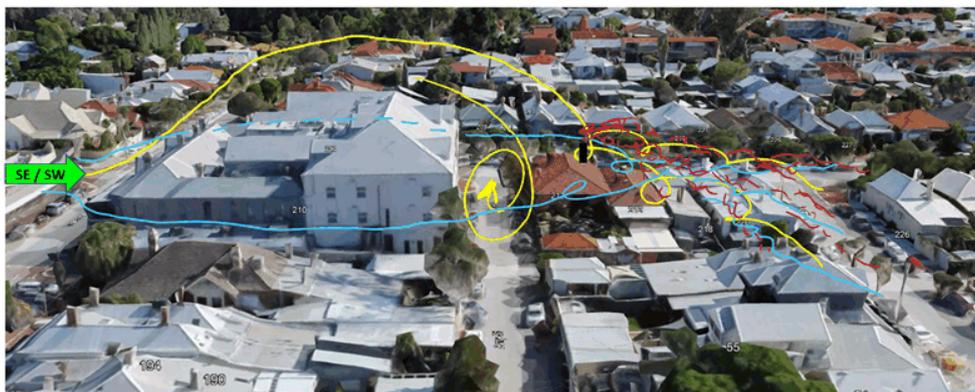
**Figure 11:** Grounding plume under a SE/SW wind

**Figure 11** shows a representation of a SE to SW wind affecting the plume emitted by the restaurant. Under these wind conditions, a cavity is formed at the top of the Northbridge hotel with the downwash effect happening at the back of the building (shown in yellow lines). Wind also travels around the side of the building and then rises above the roofs of the restaurant and residences between Amy and Ruth Streets (shown in blue lines). The building wake and zone of recirculation at the back of the building cascades down onto the roofs of the residences on the other side of Amy Street. As such, the plume emitted from the restaurant's stack is not able to rise but is pushed down to the roofs' level and then to the level of the surrounding streets (shown in red lines).

It should be noted that an increase of the height of the stack by several meters would not solve the issue due to the presence of the large structure of the Northbridge hotel. The plume will still be emitted below the roof level of the hotel and will therefore be subject to the downwash effect of this building.

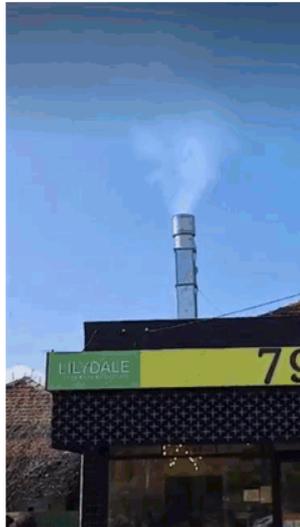
**Figure 12:** Vertical rise of the plume under no to very light wind

The first test occurred on the 27<sup>th</sup> of August 2021. There was barely any wind, and it could be observed that the plume rose vertically to the atmosphere. This is what happened during OP #2, OP #5 and partly during OP #6. In this instance, the plume is diluted and either does not ground or if it does, the odour concentration in the plume is likely below the odour recognition threshold.

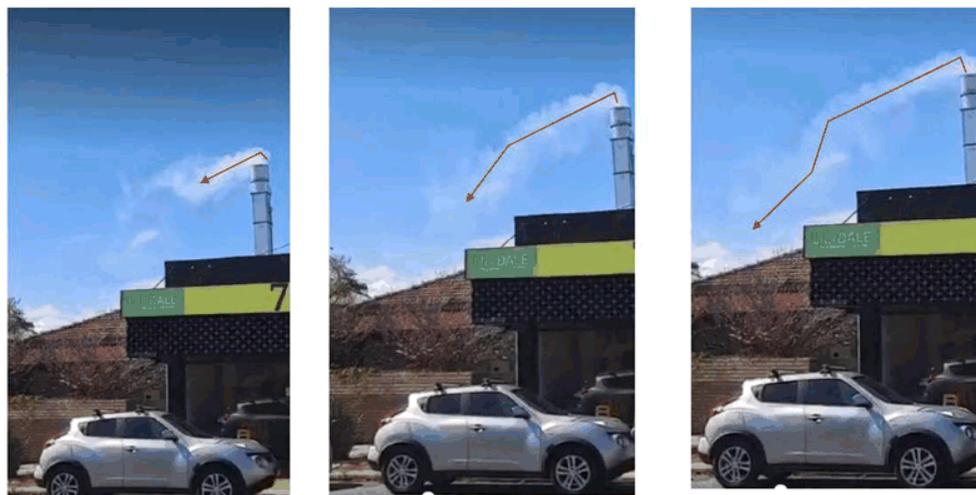
**Figure 13:** Sequence #1 – plume pushed down by downwash effect

A second test occurred on the 2<sup>nd</sup> of September 2021 under a stronger WSW/SW wind (15 to 28 km/h). Under these wind conditions, the cavity above the Northbridge hotel cascaded down to Amy Street and onto the restaurant’s roof. The plume emitted by the stack was caught in the downwash effect mainly due to the hotel building downwash effect. On Figures 13 and 14, the two sequences of photos show that the plume could not rise but was pushed down to the adjacent roofs. From the roofs and with the downwash effect at the back of the residences, the plume reached ground levels in the streets, lanes, or courtyards of surrounding residences.

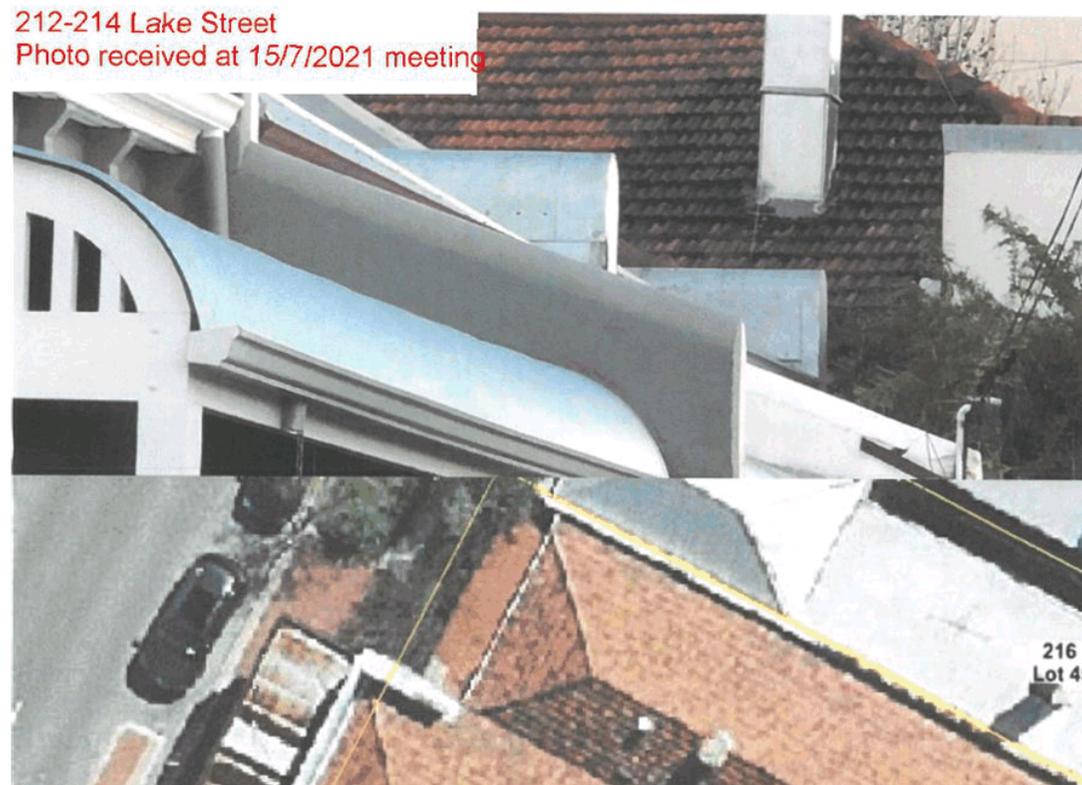
**Appendix 3: Black stain on the roof around the new stack**

**Appendix 3** presents a document provided by a resident showing a black stain on the roof around the new stack.

The company that installed the new extraction ducting and stack was contacted. The dark stain is from the waterproofing that was put in place to avoid leaks following the installation of the stack. This stain is not related to any leaks of the exhaust fumes from the ducting or the fan. The whole ducting (ceiling cavity and roof) has been tested for leak detection including leaks at the flange joints. The ducting is correctly sealed, and a strong extraction can be felt at the level of the hood indicating an efficient extraction of the cooking fumes.
