BEATTY PARK LEISURE CENTRE

CONSERVATION PLAN

Vincent Street, North Perth September 2007

for the Town of Vincent

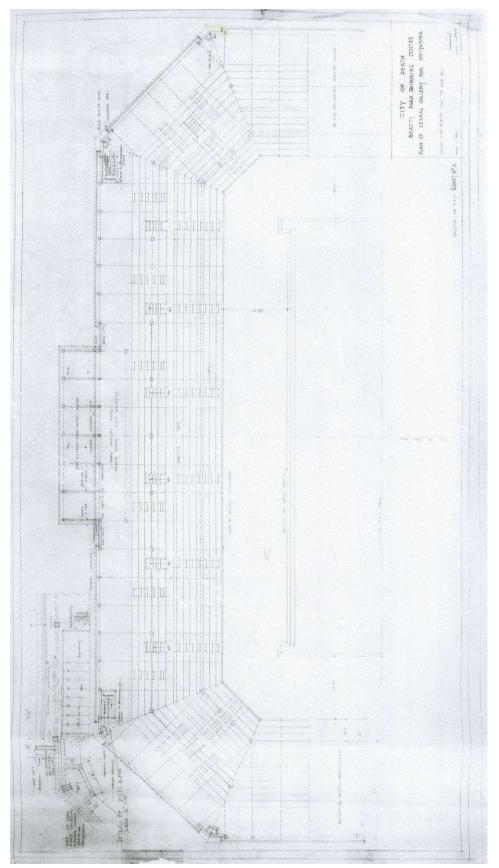
Figure 1 Plan of Central Gallery for Spectators, City of Perth *Beatty Park Swimming Centre*, Sheet no. 3, May 1961, revised 24 July 1961, SROWA Cons. 5094, Item 1837.

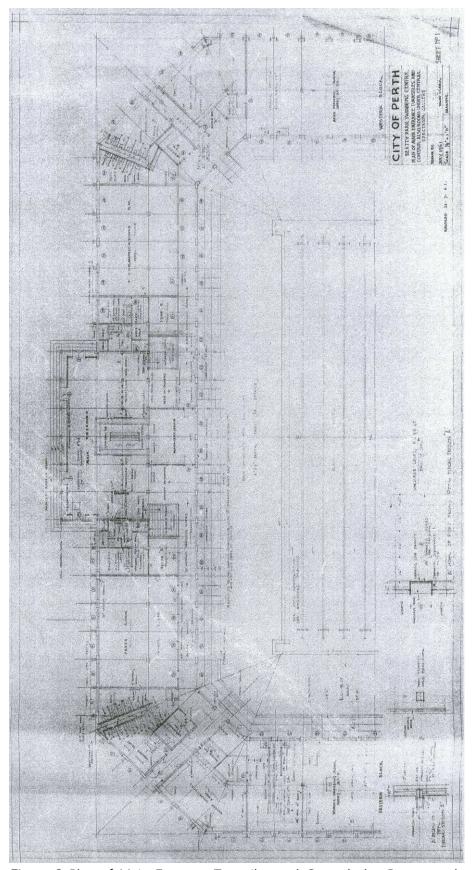
Figure 2 Plan of Main Entrance Turnstiles and Control also Rooms under Central Spectators' Gallery, City of Perth *Beatty Park Swimming Centre*, Sheet no. 1, July 1961, revised 28 July 1961, SROWA Cons. 5094, Item 1837.

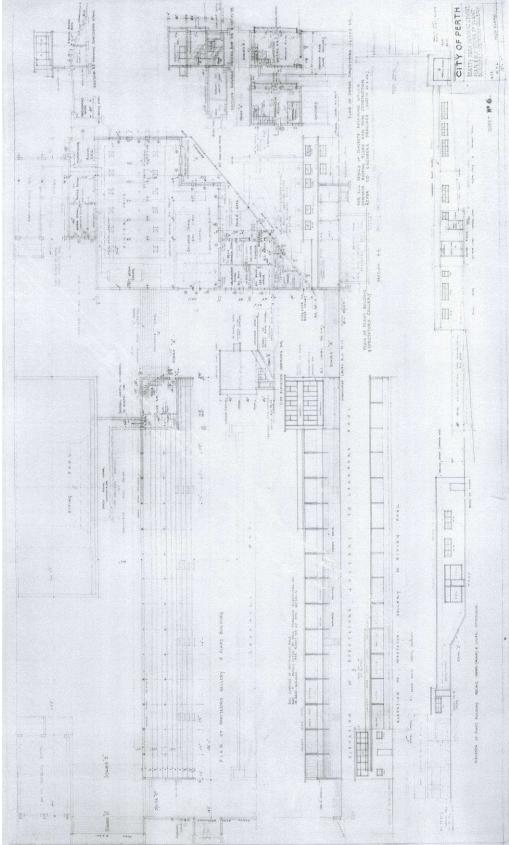
Figure 4 Plan & Elevations of Plant Building and Spectators' Gallery, City of Perth *Beatty Park Swimming Centre*, Sheet no. 6, 31 July 1961, SROWA Cons. 5094, Item 1837.

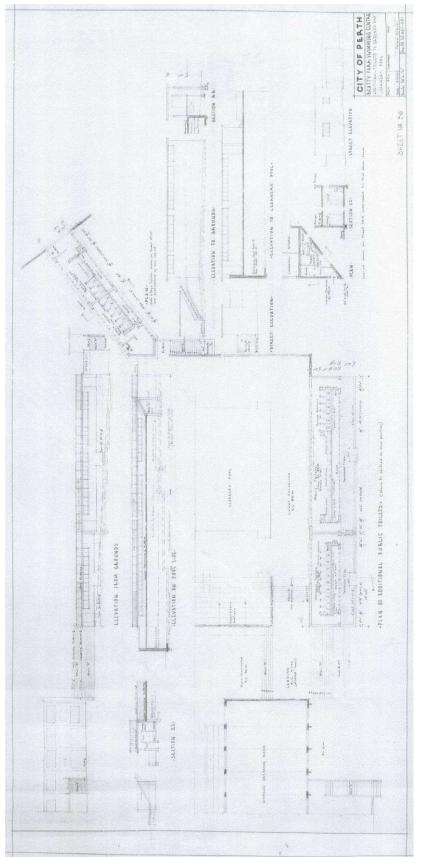
Figure 5 Additional Toilet Accommodation to Grounds and Learners' Pool, City of Perth *Beatty Park Swimming Centre*, Sheet No. 38, September 1961, SROWA Cons. 5094, Item 1837.

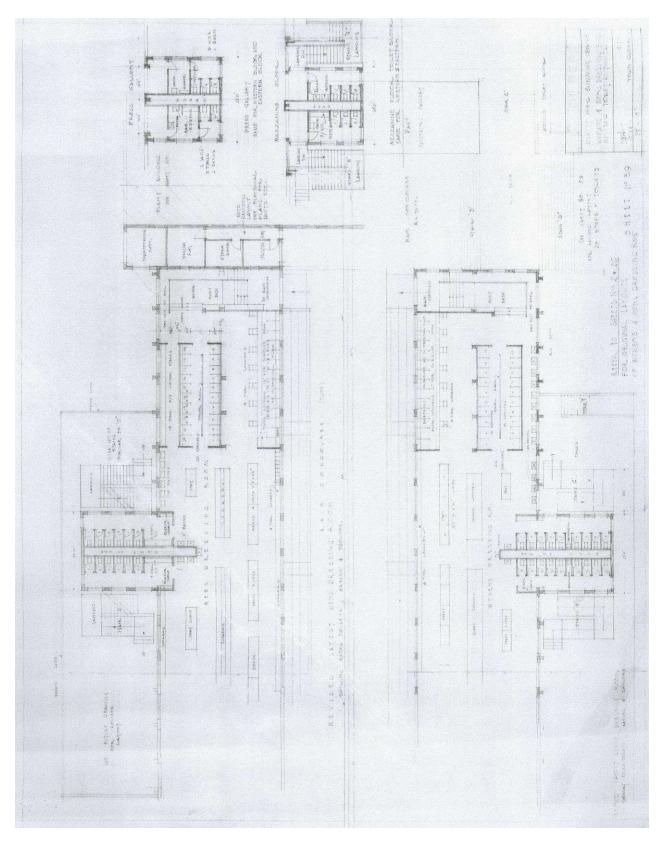
Figure 6 Women's and Men's Dressing Rooms, Revised Toilet Accommodation, City of Perth, *Beatty Park Swimming Centre*, Sheet No. 39A, September 1961, SROWA Cons. 5094, Item 1837.

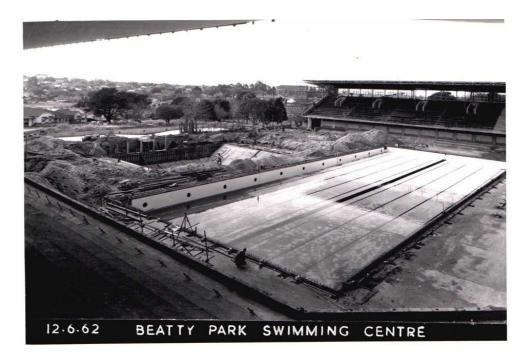
Touch boards for the swimming pool would be provided by the well-known Swiss firm of Longines, on loan to the Games Committee for the duration of the Games.⁹² In June 1962, a photograph shows the spectator gallery with its roof as fitted in December 1961, and work in progress on the main pool and the diving pool.⁹³

Photo 6 Aquatic Centre, *Beatty Park*, 12 June 1962, courtesy Town of Vincent Library. Note work to date on spectator stands, main pool and diving pool.

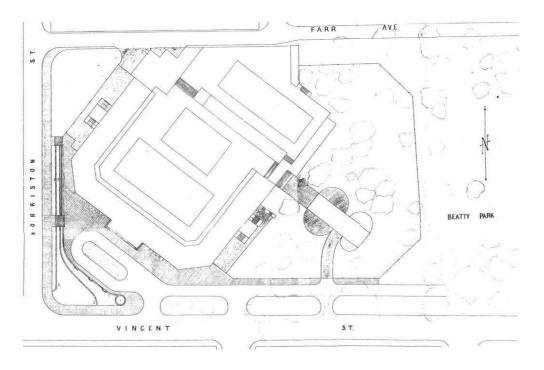
Figure 8 City of Perth, *Beatty Park* Swimming Centre, Site Plan, K.C.E.D., 6 August 1962, in Aquatic Centre . The plan shows changes made to the walling proposals along the Morriston Street frontage.- General- *Beatty Park*, City of Perth, SROWA AN 20/5 Acc. 3054 Item 61 (1963).

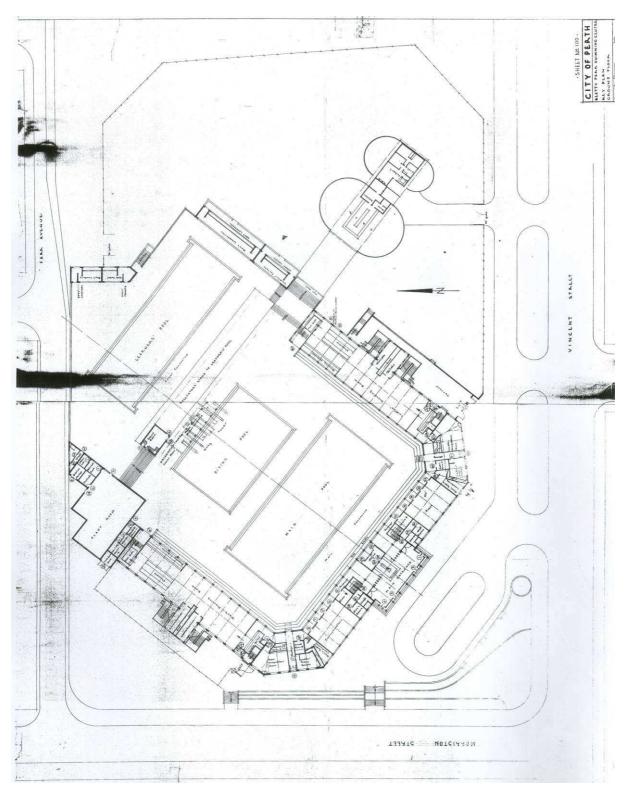
Figure 9 City of Perth, Key Plan, Ground Floor, *Beatty Park* Swimming Centre, Drawing no. SP-61/1-100, signed as drawn by GPD, 17 October 1962. At the diving pool, note the observation tower, and the photo room beneath the concourse.

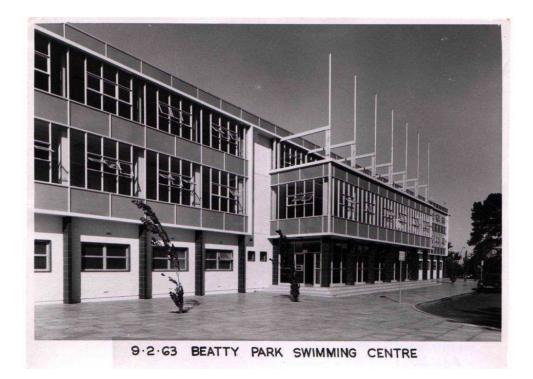
Photo 14 Main entrance, City of Perth Aquatic Centre, Beatty Park, 9 February 1963, courtesy Town of Vincent Library.

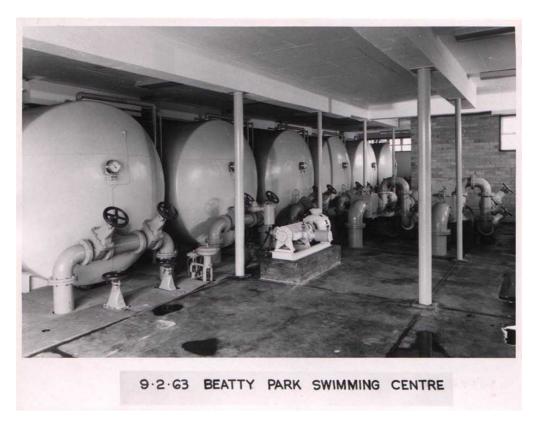
Photo 22 Interior of plant room, City of Perth Aquatic Centre, Beatty Park, 9 February 1963, courtesy Town of Vincent Library.

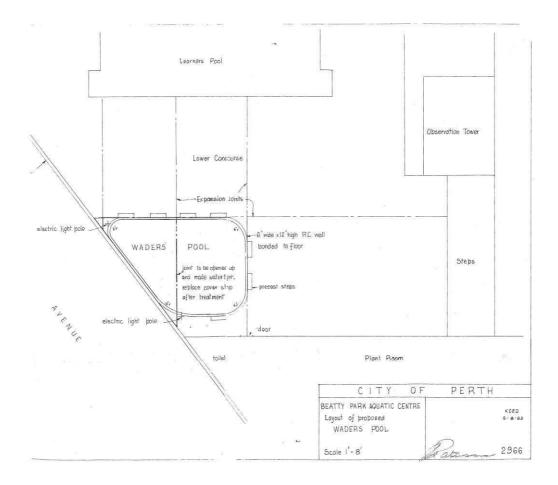
Figure 11 Beatty Park Aquatic Centre, Layout of proposed Waders' Pool, signed K.E.C.D., in Beatty Park Aquatic Centre Construction, Perth City Council File 85/89, February 1963-June 1981, 5 August 1963.

estimated cost of £775.¹²⁸ The existing concourse tiles within the designated area were to be left undisturbed and would form the floor of the new pool, other than where a concrete up-stand was to be bonded to the concourse slab and a concrete kerb constructed, which was to be tiled in a mosaic pattern 'to allow for curvature.'¹²⁹ As the proposed pool would cover one of the main expansion joints to the concourse, that joint was to be specially treated and the cover strip replaced. Good lighting would be provided by two existing pole type concourse lights at each end of the proposed wading pool.¹³⁰

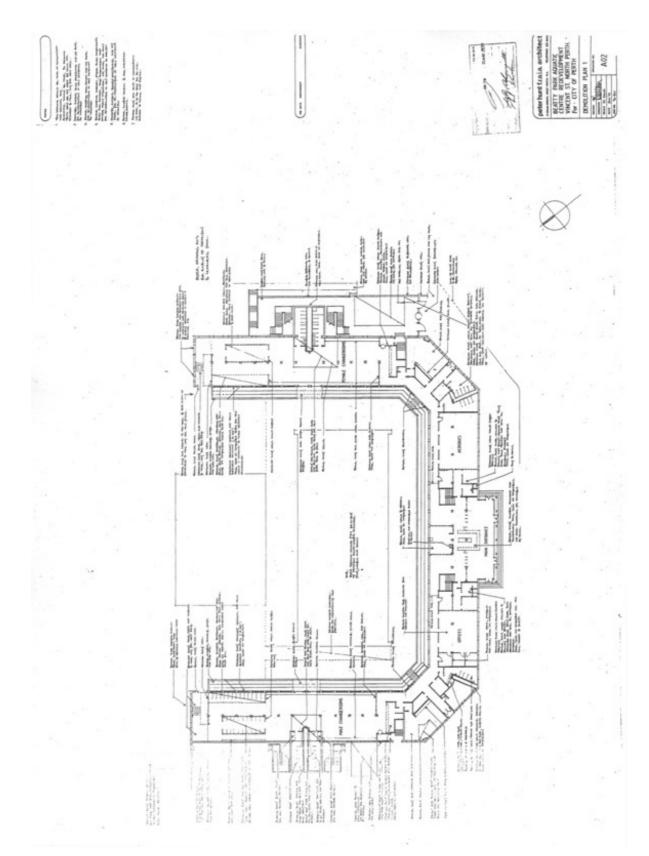
Figure 18 Demolition Plan 1, Peter Hunt Architect, Beatty Park Aquatic Centre Redevelopment for City of Perth, Drawing No. A02, January 1993. Note demolition of various walls and floors, removal of some ceilings, and various fixtures and fittings.

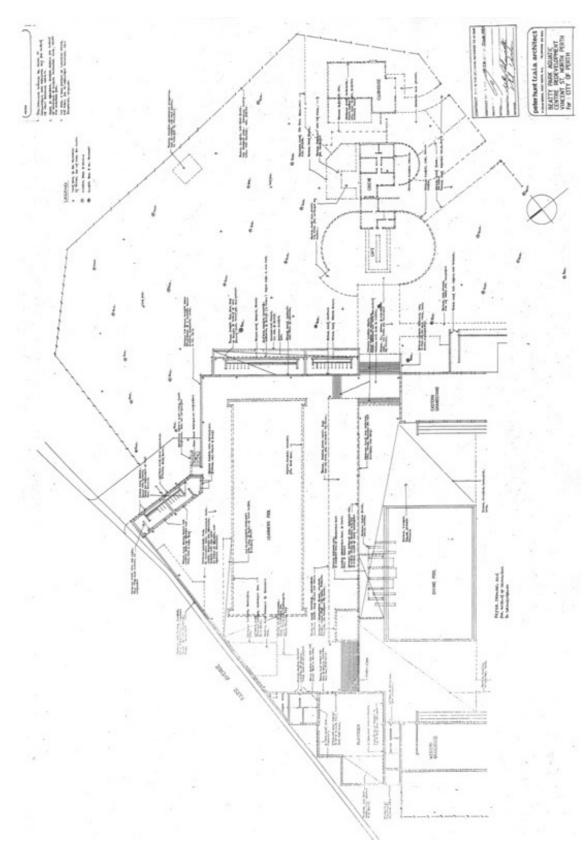
Figure 19 Demolition Plan 2, Peter Hunt Architect, Beatty Park Aquatic Centre Redevelopment for City of Perth, Drawing No. A03, January 1993. Note demolition of diving tower, existing café, crèche and clubhouse.

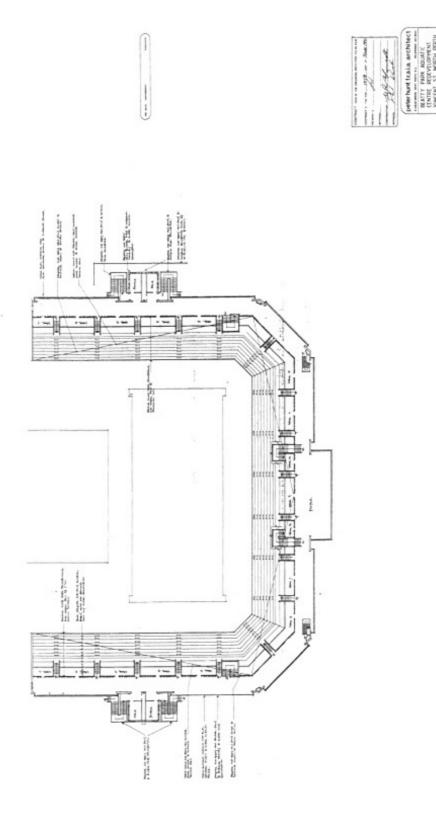
Figure 20 Alterations to existing grandstand, Peter Hunt Architect, Beatty Park Aquatic Centre Redevelopment for City of Perth, Drawing No. A35, January 1993.

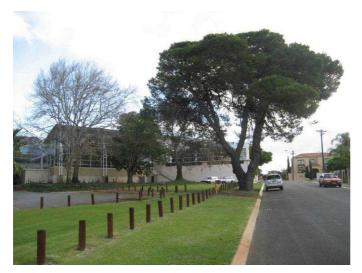
View of *Beatty Park* looking west along Swimming Avenue. Large Monterey Pine, London Plane and Queensland Box trees provide ample shade for streetcar parking and largely obscure the view of the *Beatty Park Leisure Centre* addition to the place.

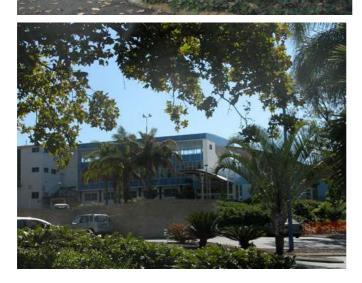
Photo 34

The present main entry marked by the curved roof is seen partially hidden in the background with some Cocos Palm trees flanking the entry. The entry is part of the 1994 additions program (right), with the original 1962 stands to the left.

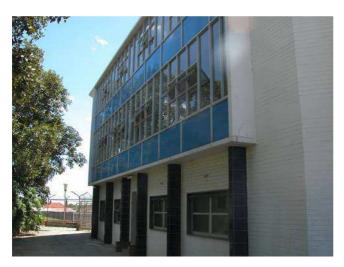
A view of the western elevation of the Perth Aquatic Centre. The dark blue tiled columns on the ground level present a strong emphasis on verticality that stands out against the horizontality of the light blue spandrels on the upper two levels.

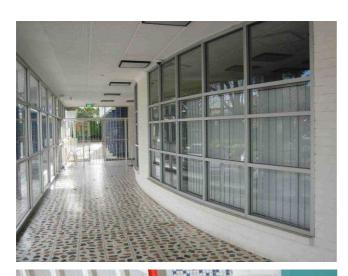
The terrazzo tiles line the lobby floor in the former main entrance (G13) (presently divided into offices), denoting the significance of the space. The partitions were part of the 1994 works. The turnstiles used to be located here.

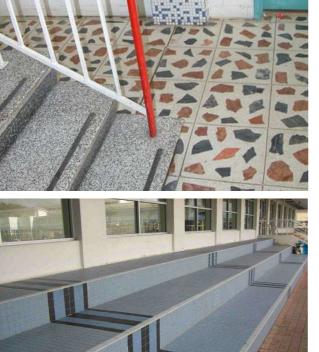
Photo 52

Blue tiled steps showing signs of discolouration provide access down from the change room floor to the pool terrace and act as seating for poolside spectators (G11). Coloured concrete blocks mark a paving change to the pool area. All of this material was part of the refurbishment work in 1994.

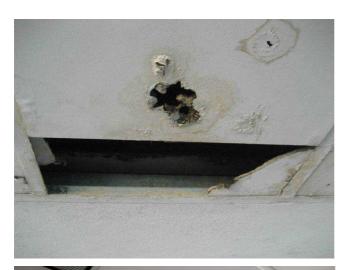
Damp penetration along the mezzanine concourse area (M42) has caused the ceiling to start peeling and deteriorating.

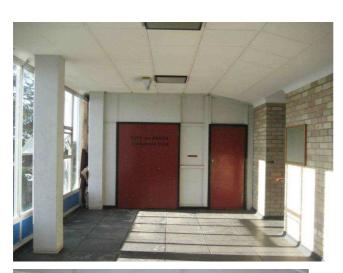
Photo 64

Note the diagonal cracking and peeling ceiling in the area above the City of Perth Swimming Club Clubrooms (M42).

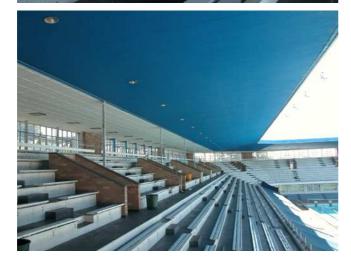
Storage spaces are hidden below the tiered seating on the mezzanine level (M48). The spectator gallery has not been altered since construction of the original 1962 building. Seats or plats are showing signs of discolouration.

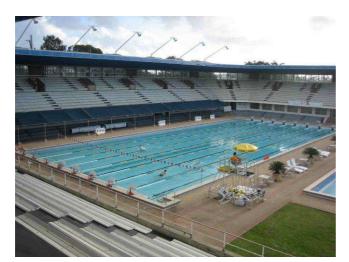
A view of the spectator gallery on the mezzanine level (M48), which is equipped with timber batten seats fixed to the face of pre-cast concrete terraces. The balustrades consist of steel balusters and rails, and a plastic wrapped handrail. This simple material treatment is used consistently for the stairs in other areas of the building. The *Leisure Centre* building lies beyond.

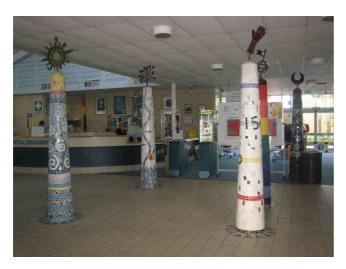
Mosaic tiled abstract totem figures by Paul O'Connor sit in the new entry foyer (N7) lined with ceramic tile flooring.

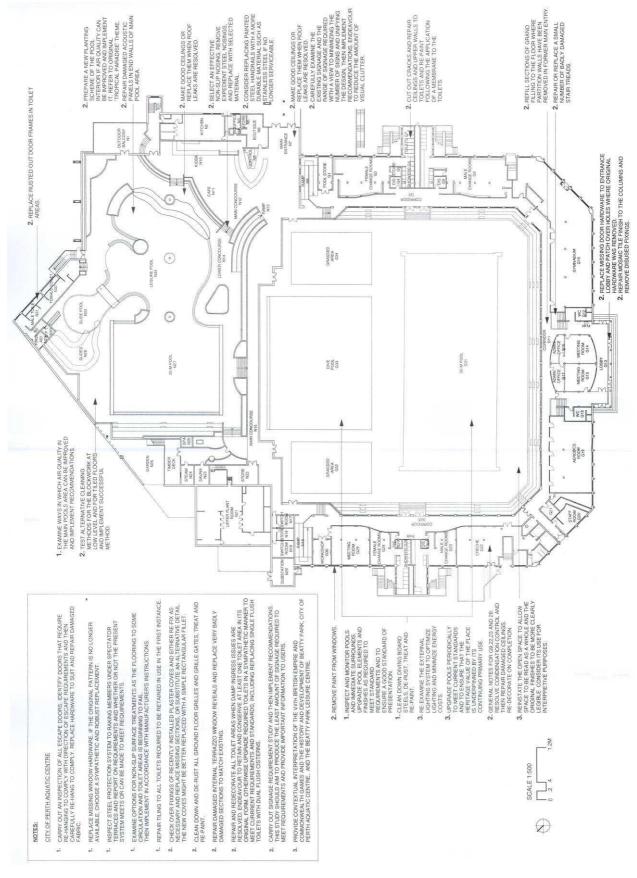
Figure 38 Beatty Park Leisure Centre – Ground Floor Plan (Conservation Works).

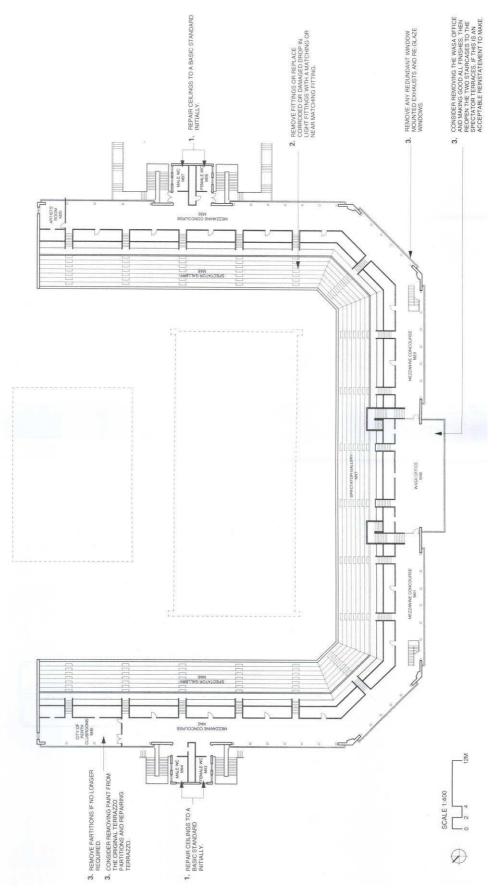
Figure 39 Beatty Park Leisure Centre – Mezzanine Floor Plan (Conservation Works).

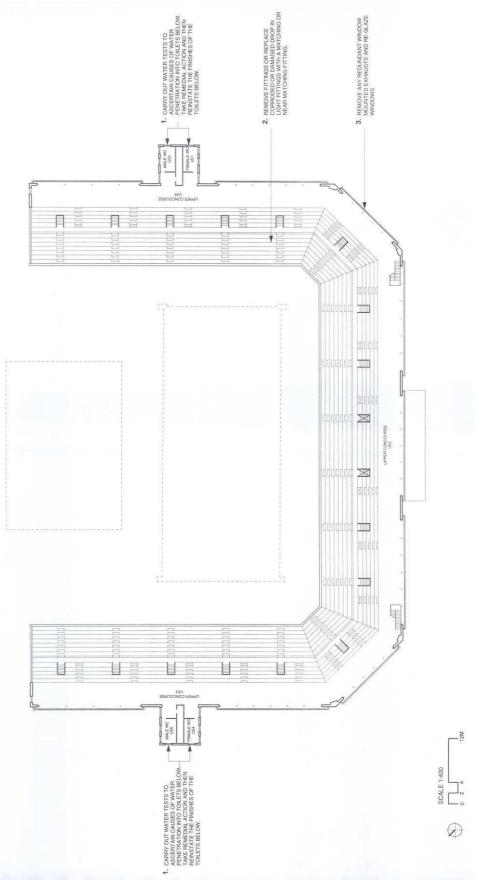
Figure 40Beatty Park Leisure Centre – Upper Floor Plan (Conservation Works).

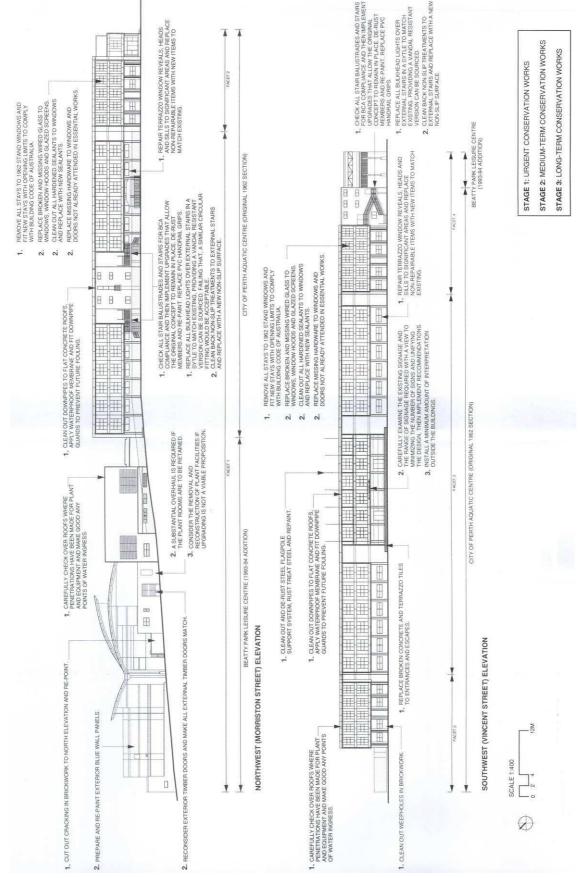
Figure 41 Beatty Park Leisure Centre – NW & SW Elevations (Conservation Works).

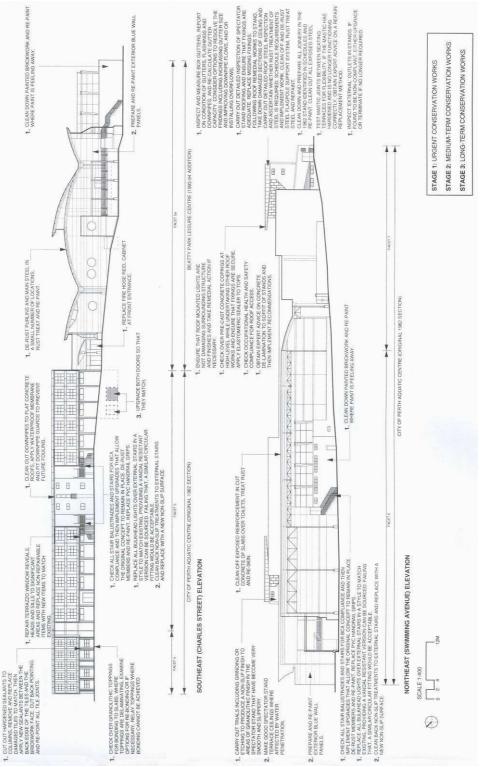
Figure 42 Beatty Park Leisure Centre – SE & NE Elevations (Conservation Works).
