SEWERAGE VENT, STUART STREET RESERVE, PERTH

PLACE INFORMATION	
Place name	Sewerage Vent, Stuart Street Reserve
Other names	
Place type	Other Structure

HERITAGE LISTING	
inHerit ID:	23777, 23992
State Heritage Register:	11 Sept 2015
Other Listing:	Municipal Inventory Adopted 28 Jun 2016

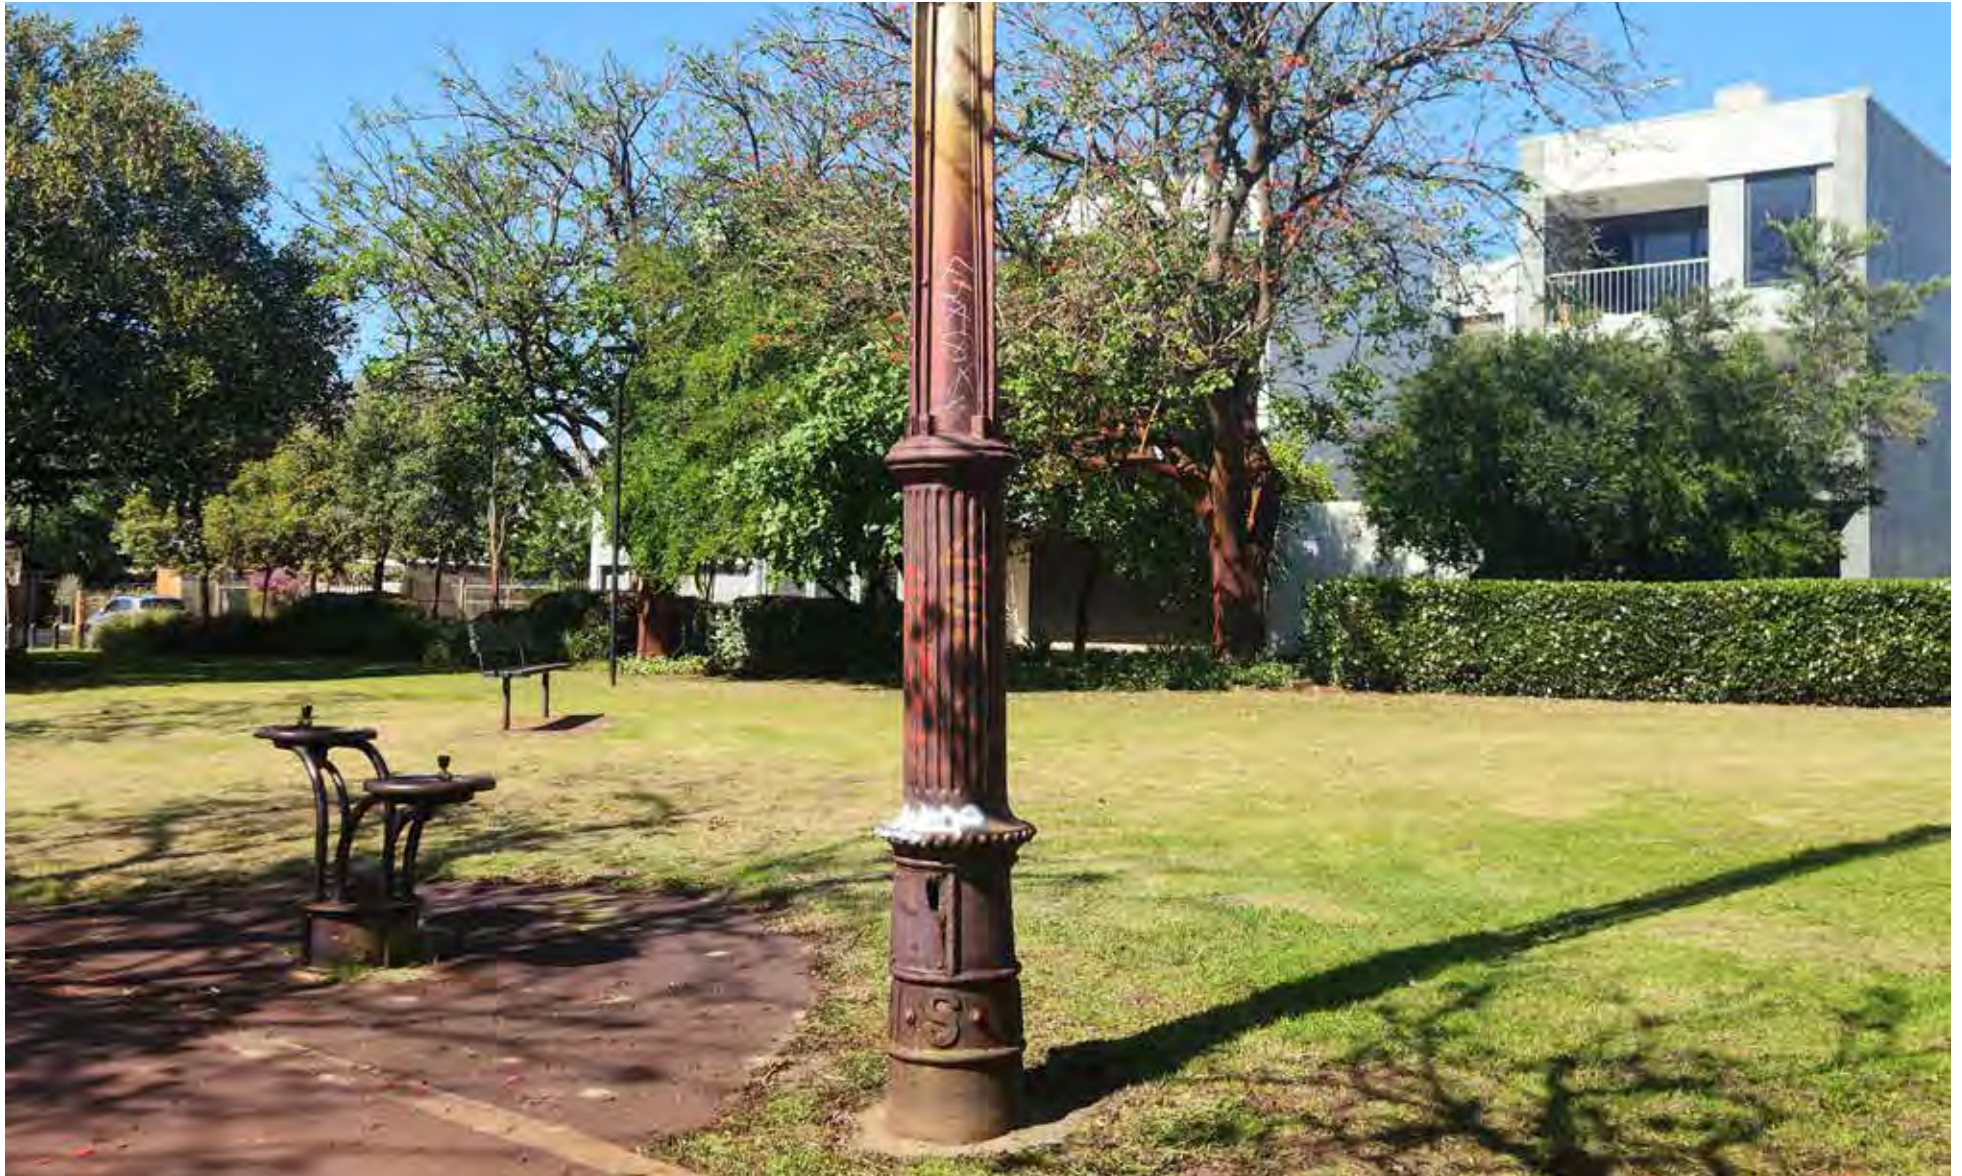
PLACE USE	
Original use	Health: Other Government: Other
Current use	Historic site
Other use	
CONSTRUCTION DETAILS	
Construction date	c1912
Walls	Cast Iron
Roof	N/A
Architectural Style	N/A
Physical description	<p>The vent comprises an ornate circular cast iron base with fluting and moulding which contains the letters M S (Metropolitan Sewerage) in the lower portion.</p> <p>An access panel, measuring approximately 20cm by 10cm and secured by a bolt in each corner, provides visual access into the vent. The base has been painted bronze with scarlet lettering.</p> <p>The bases are approximately two metres high, set below a straight circular pipe braced by four metal rods that rise out of the base. The pipe comprises several segments connected together, each approximately a metre in length and between 5–10 cm in diameter. The bottom section of piping is slightly tapered to connect to the base.</p>
Condition	Good
