9.6 AMENDMENT TO THE TREES OF SIGNIFICANCE INVENTORY TO INCLUDE THE JACARANDA TREE AT NO. 59 ELLESMERE STREET, MOUNT HAWTHORN

**59 Ellesmere Street, Mount Hawthorn Visual Tree Assessment (VTA) –
October 2022**

*Visual Tree Assessment (VTA)
1x Jacaranda mimosifolia*

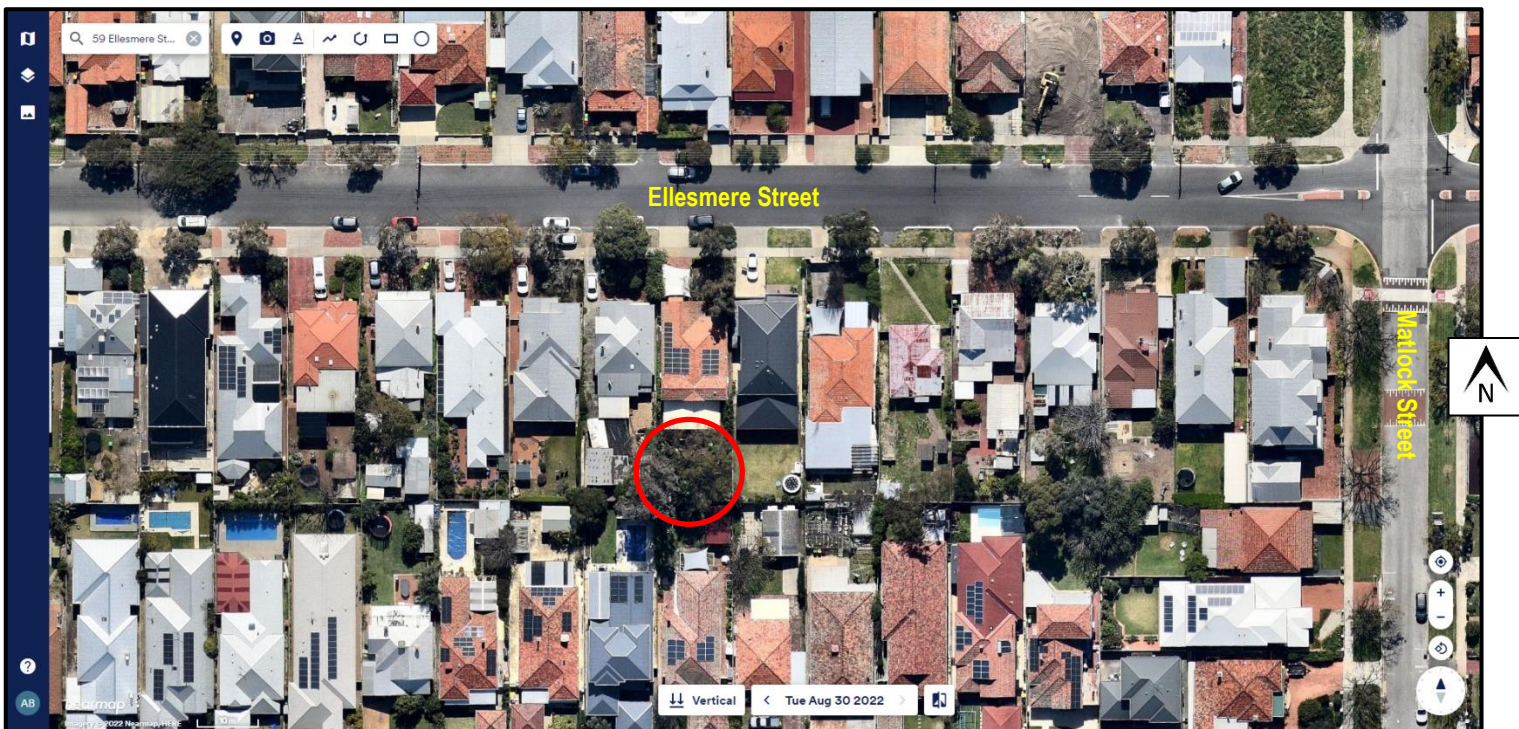
Figure 1. Tree of assessment outlined in red – image source www.Nearmap.com - image date 30th August 2022

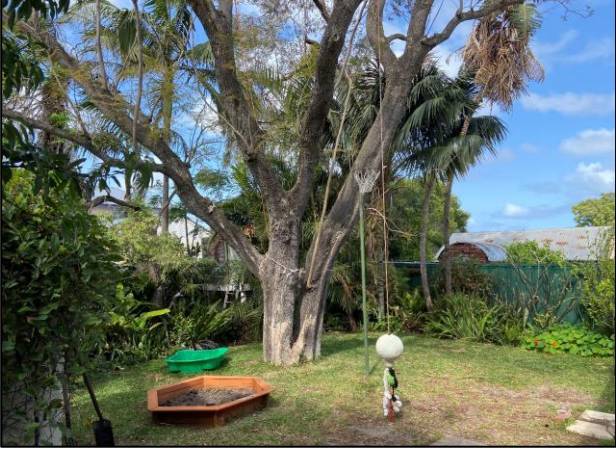
<p>Height Estimate ~ 15 (Metres) Canopy Spread ~ 15 (Metres) Diameter at Breast Height (DBH) - 0.670 (mm) Bole/Root Flare - 0.780 (mm) AS 4970 Nominal TPZ - 8.04 (Metre Radius) AS 4970 Nominal SRZ - 2.98 (Metre Radius) Estimated Life Expectancy (ELE) - 40+ Years Age - Mature Tree Type - Deciduous Tree Health - Good Tree Structure - Acceptable</p>																										
<p>Observations & Comments</p>

<table><tr> <td>Site -</td> <td>Location - Character - Landscape Features - Site History - Infrastructure -</td> <td>Tree Situated in Rear Yard Residence Turfed, Irrigated Grade Change None Noted</td> </tr><tr> <td>Canopy Structure -</td> <td>Previous Failures (mm) - Deadwood (mm) - Hollows (mm) - Rubbing/Crossing Stems (mm) - Unions - Taper - Decay - Cracks - Suppression - Symmetry - Previous Pruning - Form -</td> <td>50-100, 100-150 0-50 100-200 0-50 Acceptable Acceptable Yes - Main Stem None Noted Minor Intermediate Excessively Thinned Unique Form</td> </tr><tr> <td>Acoustic Sounding -</td> <td>Hollow Sounding - Visual Decay -</td> <td>Yes - Main Stem Yes - Main Stem</td> </tr></table>

<table><tr> <td>Site -</td> <td>Location - Character - Landscape Features - Site History - Infrastructure -</td> <td>Tree Situated in Rear Yard Residence Turfed, Irrigated Grade Change None Noted</td> </tr><tr> <td>Recommendations -</td> <td>Preliminary Recommendation - Tree Management Works - Specific Pruning -</td> <td>Retain Undertake Canopy Pruning Requirements Remedial Pruning</td> </tr></table>
