**5.6 AMENDMENT TO THE TREES OF SIGNIFICANCE INVENTORY TO INCLUDE THE JACARANDA TREE AT NO. 59 ELLESMERE STREET, MOUNT HAWTHORN**

**59 Ellesmere Street, Mount Hawthorn Visual Tree Assessment (VTA) –  
October 2022**

*Visual Tree Assessment (VTA)  
1x Jacaranda mimosifolia*

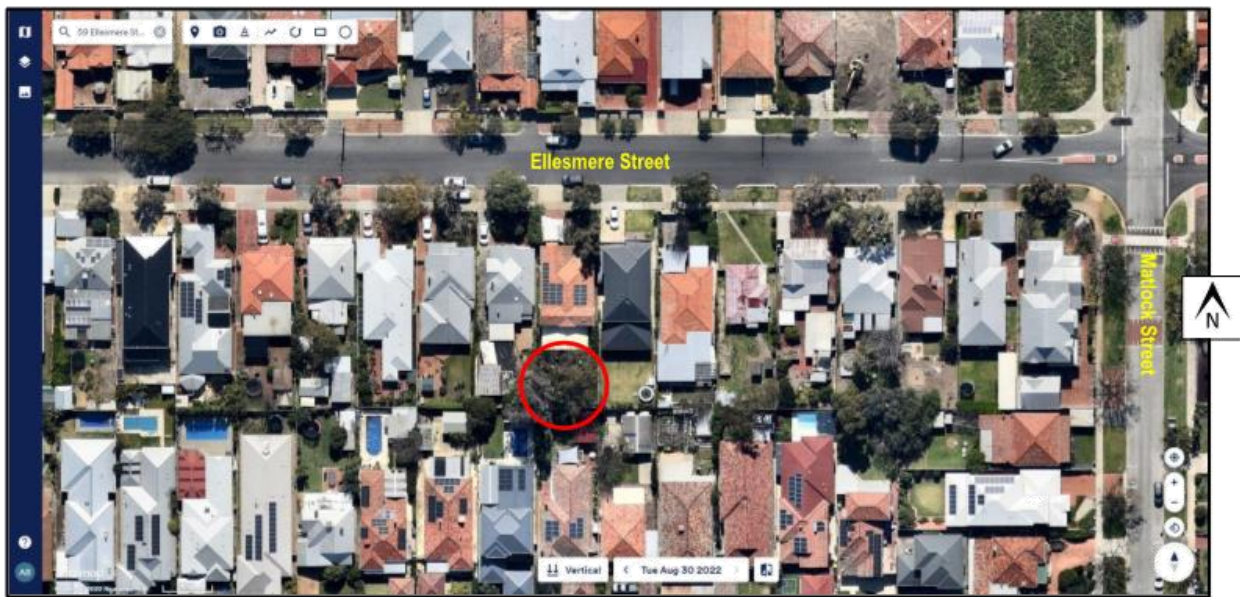
Figure 1. Tree of assessment outlined in red – image source [www.Nearmap.com](http://www.Nearmap.com) - image date 30<sup>th</sup> August 2022
