3. PHYSICAL EVIDENCE

3.1. INTRODUCTION

This section is based on a survey that was carried out in February 2003. The physical evidence was assessed by means of a thorough investigation of the context, the site and the landscape, plantings and structures that combine to form *Hyde Park*.

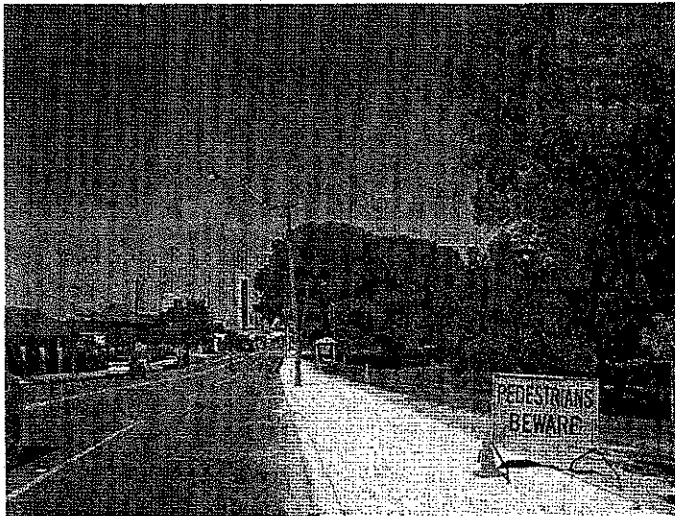
Record Photograph 4
Looking south down
William Street towards the
intersection with
Glendower Street. Note the
new concrete path.
(April 2003)

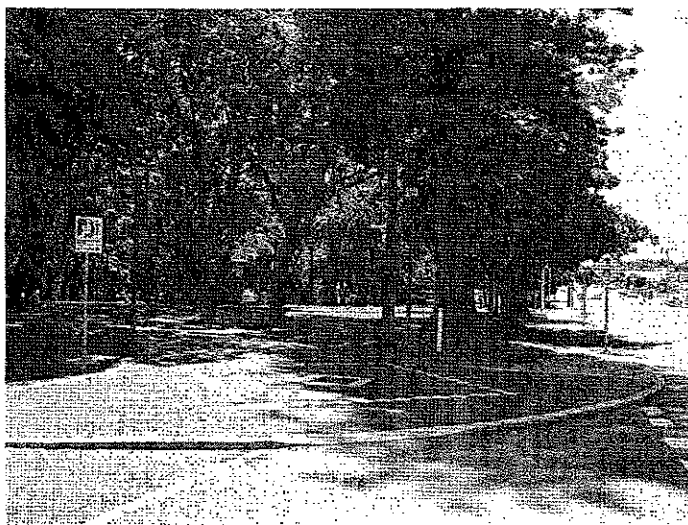
Record Photograph 7

The entrance to the park at the intersection of William and Glendower Streets.
(April 2003)

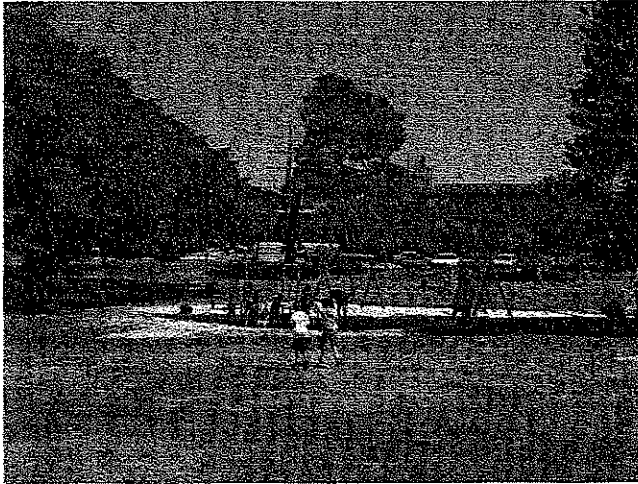
Record Photograph 20
Playground looking towards Glendower Street. Note the high voltage power lines. (April 2003)

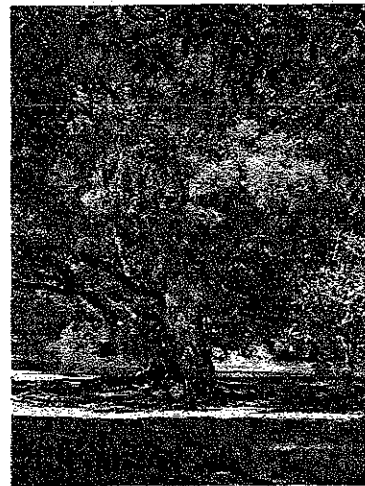
Record Photograph 25
Remnant Paperbark. (April 2003)

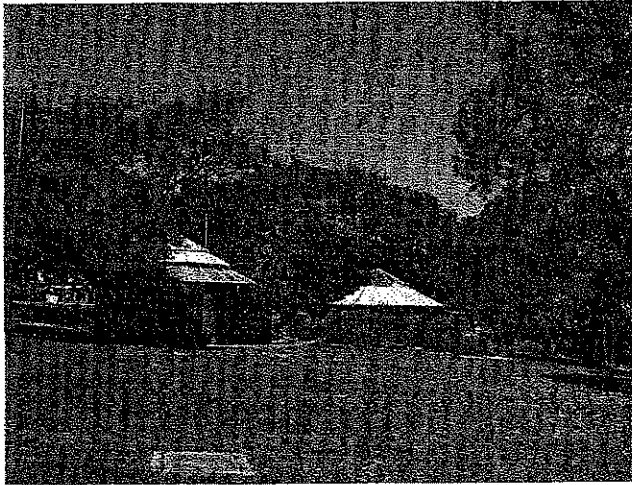
Next to the lake-side path on the western side of Section 11 is the Works Depot and a block of toilets. The Works Depot is a small irregular shaped piece of land enclosed with an 1800mm high cyclone fence with vehicle gates. An octagonal face brick building with a copper roof provides a storage area for equipment and a small meeting area for the staff. Adjacent to this building is a matching structure that houses public toilets. Plantings of trees, bushes, flowering shrubs and climbers on both sides of the fence around the depot area effectively screen it from public view. These plantings have been described in more detail in the Appendix.

Record Photograph 34
Public Toilets (left) and Works Depot (right).
(April 2003)

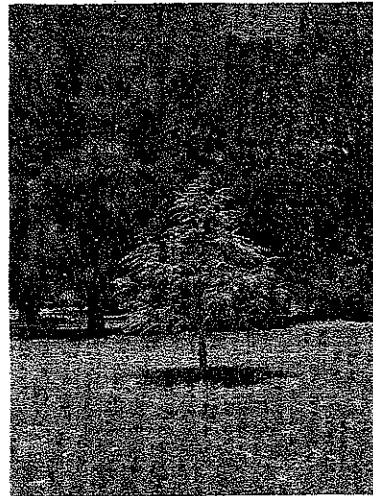
Shady trees have been planted along the edge of the paths and a mix of shady trees and sculptural trees and palms have been planted in the middle of the lawn. Specimen plantings in this area include a Woman's Tongue Tree *Albizia lebbek*, a Senegal Date Palm *Phoenix reclinata*, an Orchid Tree *Bauhinia purpurea*, a Plum Pine *Podocarpus elatus*, a Monterey Cypress *Cupressus macrocarpa*, a Tree of Heaven *Ailanthus altissima*, an Irish Strawberry Tree *Arbutus unedo* and a recently planted Himalayan Cedar *Cedrus deodara*. The juvenile Himalayan Cedar was planted to replace an earlier tree from the area that had died.

Record Photograph 35
Himalayan Cedar.
(April 2003)

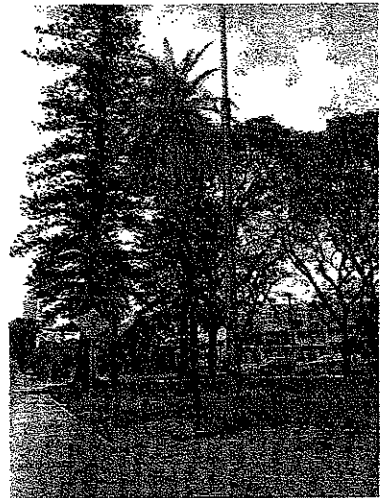
Record Photograph 38
MWS cast iron sewer vent.
(June 2003)

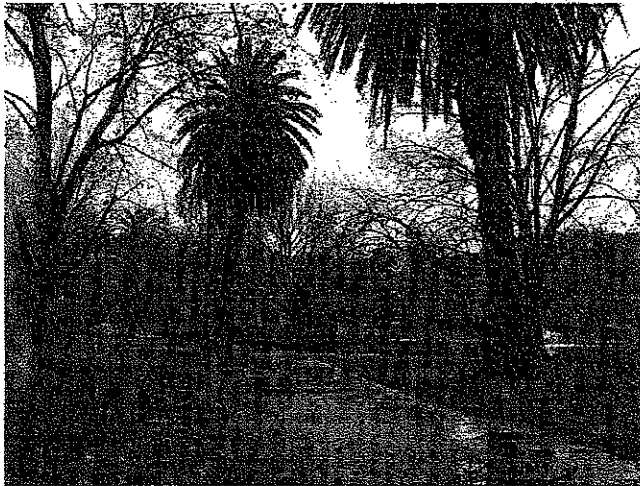
Record Photograph 45
Looking north across the
Causeway, winter. Note the vistas
across the park which have
opened up since the Plane Trees
have lost their leaves.
(June 2003)

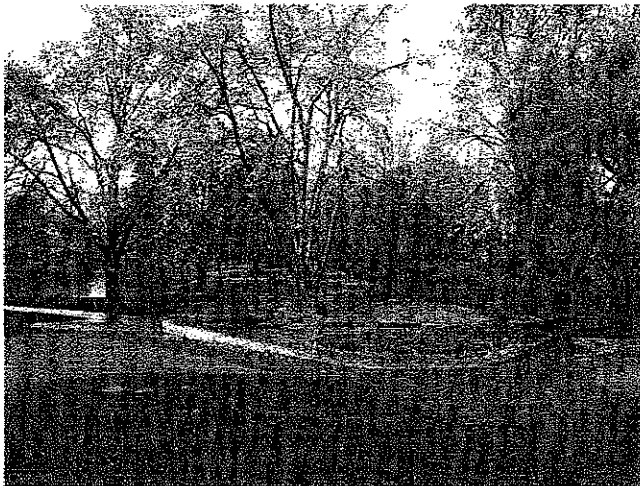
Record Photograph 46
Looking south across the
Causeway, winter. Note the
triangular garden bed with
limestone retaining walls.
(June 2003)

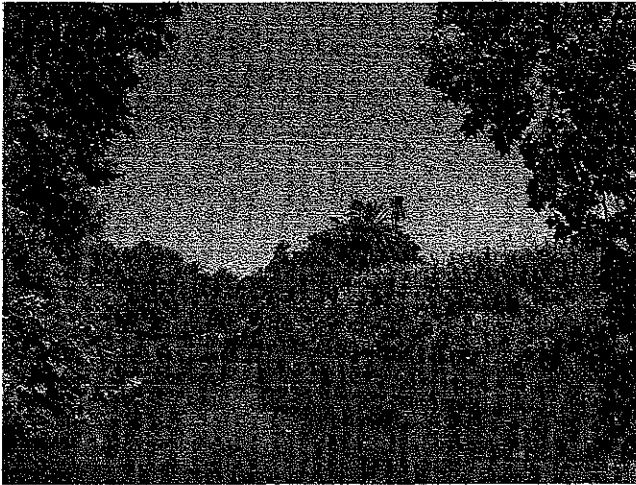
Since the island has been left to grow wild a number of species indigenous to Perth lakes have become re-established including a number of Swamp Paper Bark Trees *Melaleuca sp.*, a Paperbark *Melaleuca preissiana* and various reeds and sedges. There is also a W.A. Peppermint Tree *Agonis flexuosa* and a Bottlebrush *Callistemon sp.* that were probably self sown from plantings within the park.

At the west end of the island there is a metal frame that originally held a light fitting that illuminated the lake at night but it would appear not to have been in use for many years.

Record Photograph 47
South side of East Island.
(April 2003)
