# SEWERAGE VENT HYDE PARK, HIGHGATE

PLACE INFORMATION	
Place name	Sewerage Vent, Hyde Park, Highgate
Other names	
Place type	Other structure

HERITAGE LISTING	
inHerit ID:	23781 23992
State Heritage Register:	11 Sept 2015
Other Listing:	Municipal Inventory Adopted 28 Jun 2016

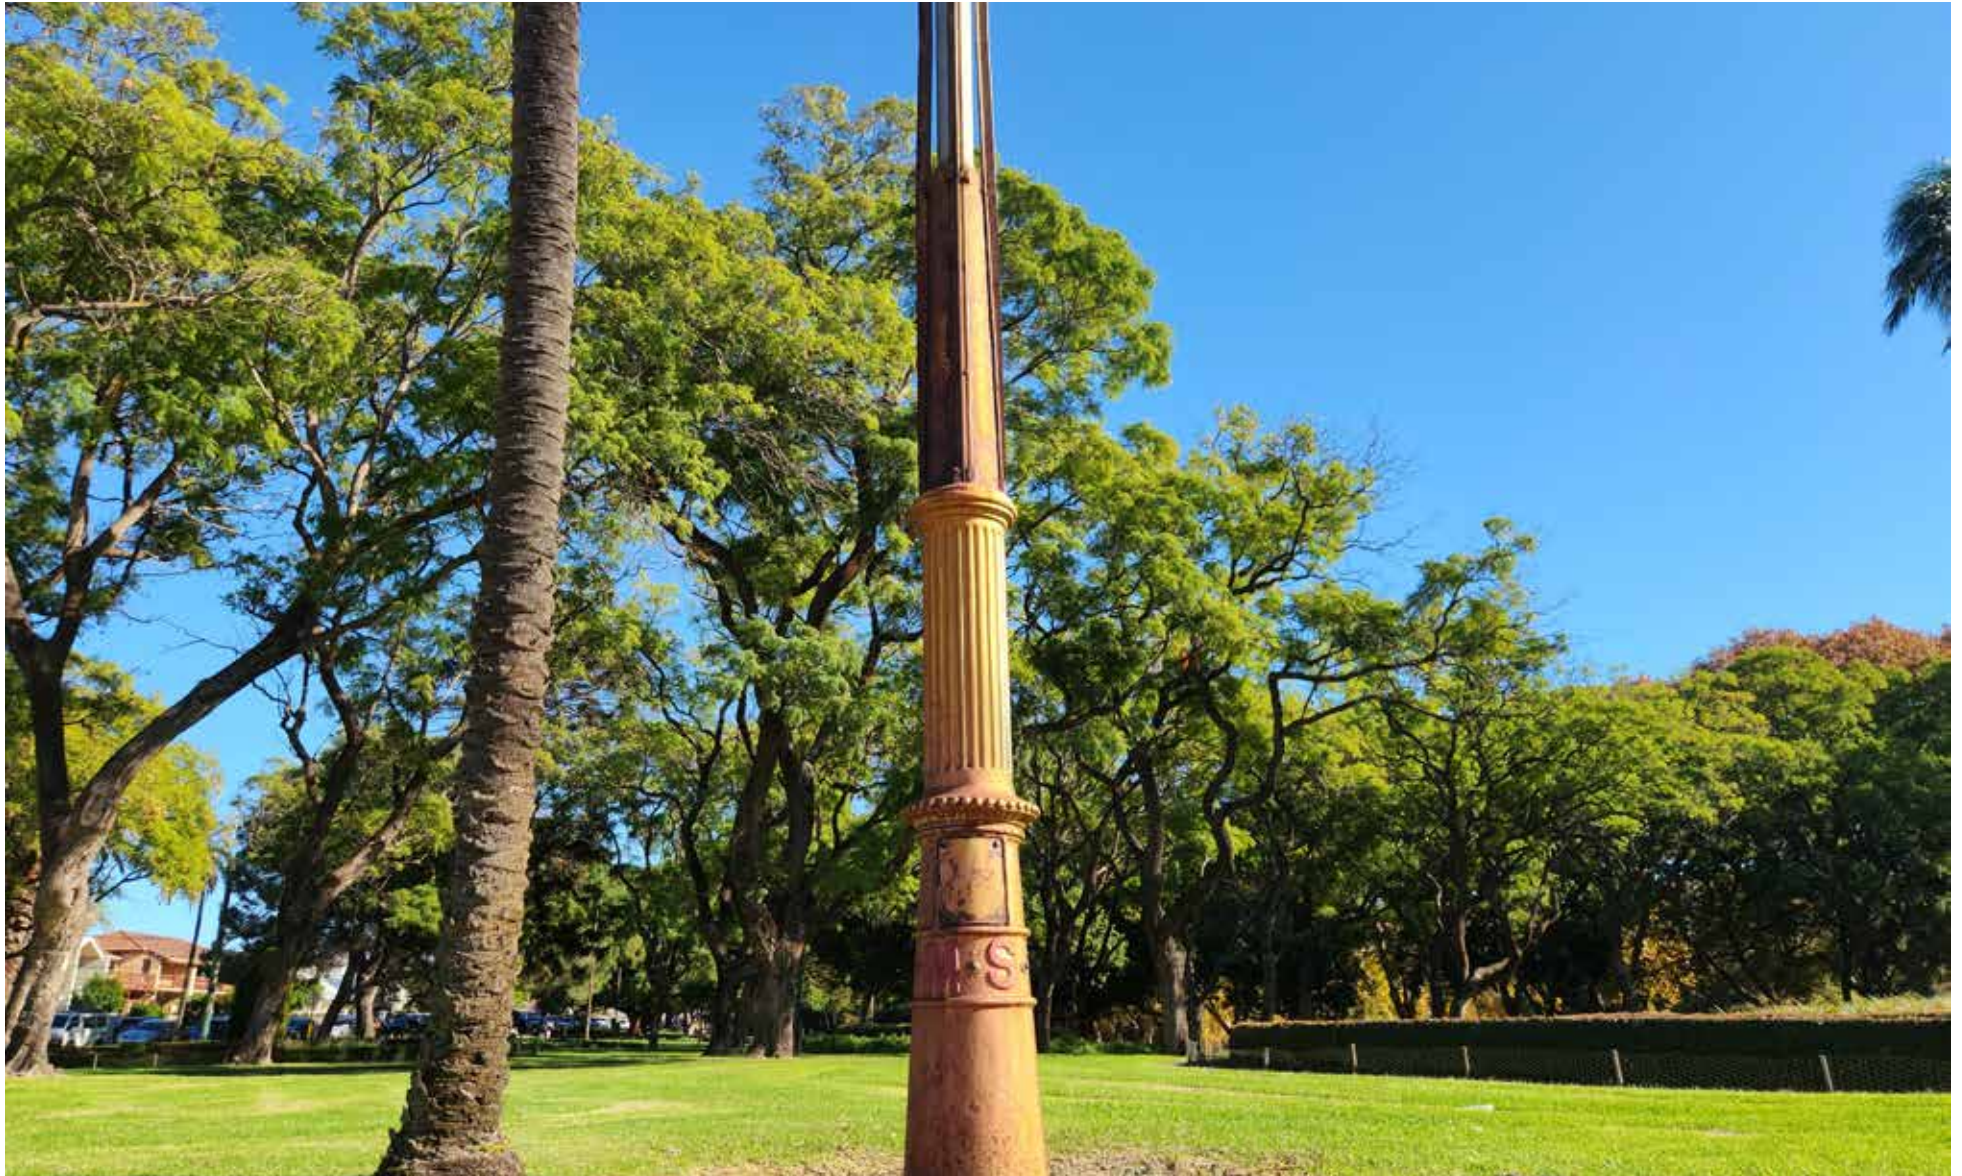
CONSTRUCTION DETAILS	
Construction date	1918-19
Walls	Cast Iron
Roof	N/A
Architectural Style	N/A
Physical description	<p>The vent comprises an ornate circular cast iron base with fluting and moulding which contains the letters M S (Metropolitan Sewerage) in the lower portion.</p> <p>An access panel, measuring approximately 20cm by 10cm and secured by a bolt in each corner, provides visual access into the vent. The base has been painted bronze with scarlet lettering.</p> <p>The bases are approximately two metres high, set below a straight circular pipe braced by four metal rods that rise out of the base. The pipe comprises several segments connected together, each approximately a metre in length and between 5–10 cm in diameter. The bottom section of piping is slightly tapered to connect to the base.</p> <p>The vent is set into a concrete base and is located adjacent to the William Street footpath within Hyde Park.</p>
